City of Lawrence

# Lawrence Field Operations Facility

## Existing Facility Condition Narratives

DAKE | WELLS  
architecture

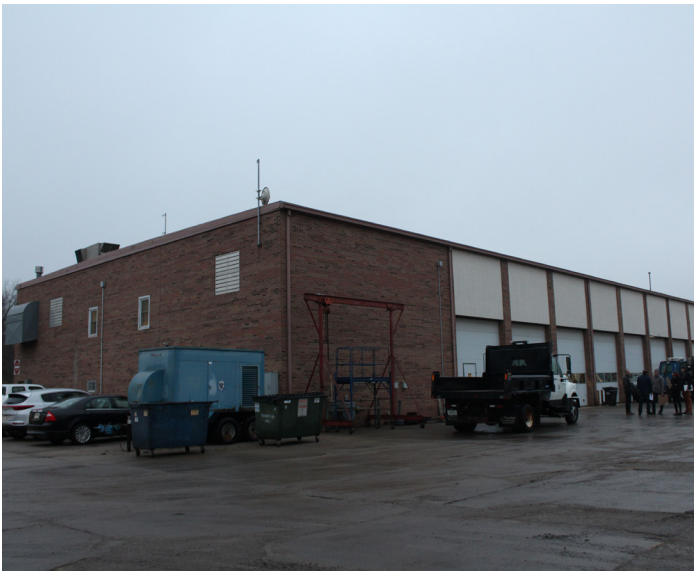
Exterior - good condition

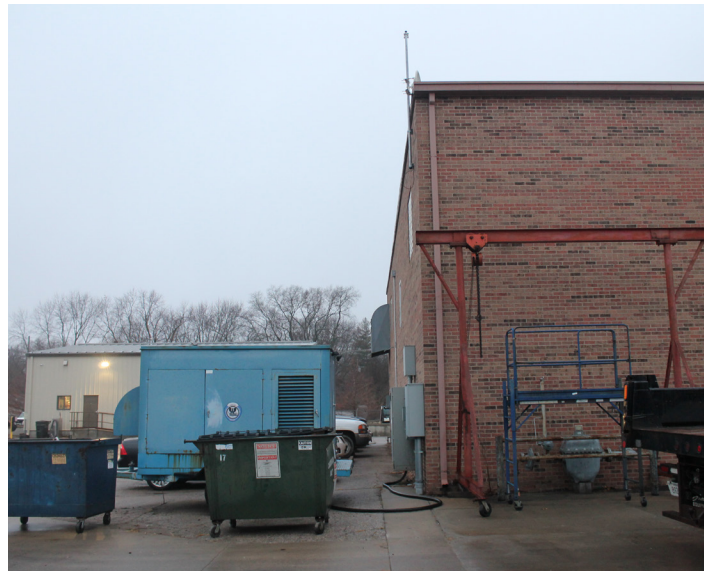
Exterior - good condition

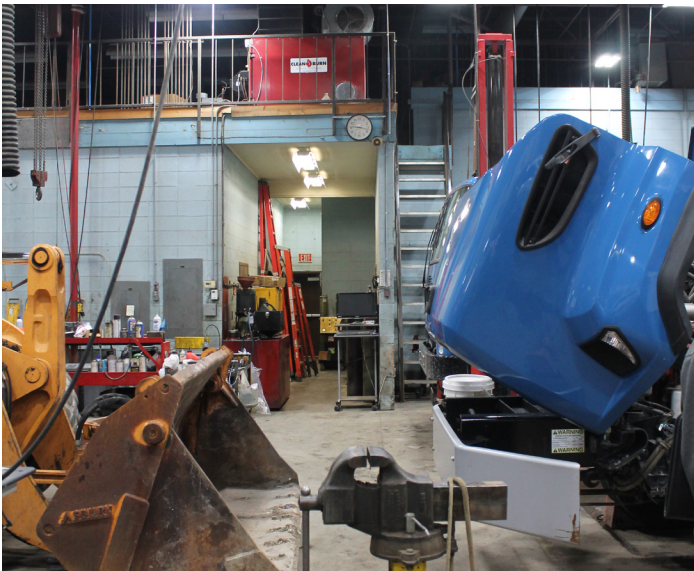
Concrete floor; painted CMU walls, exposed steel structure , fair condition

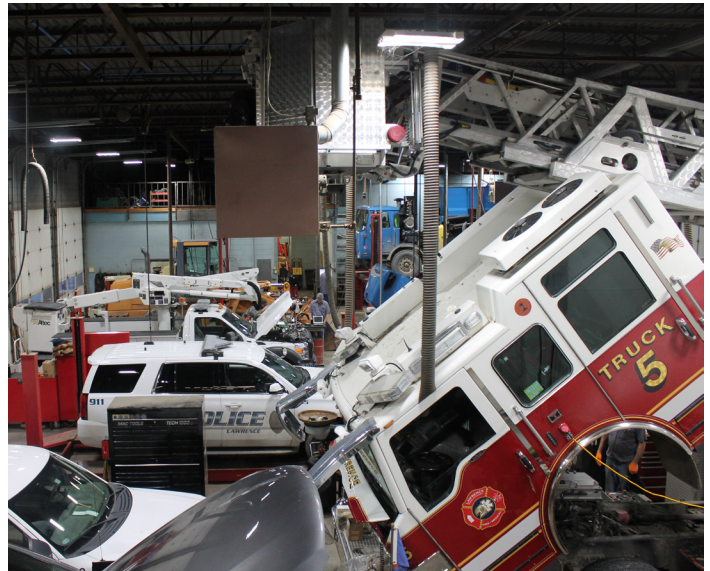
Concrete floor; painted CMU walls, exposed steel structure , fair condition

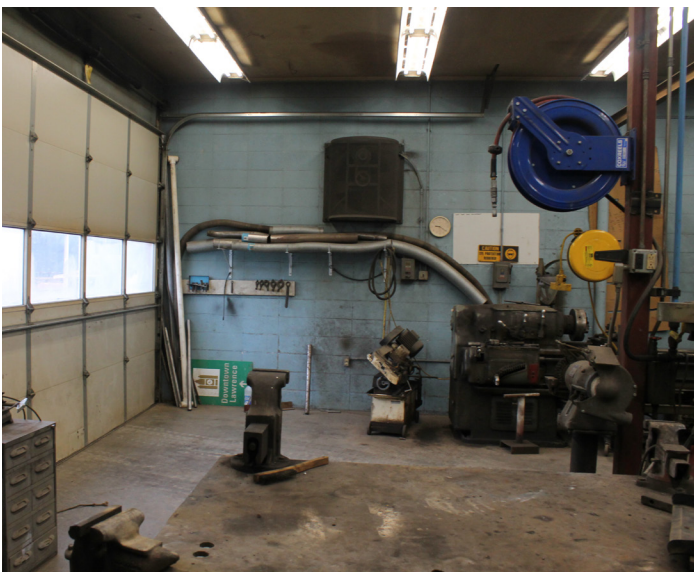
Concrete floor, painted CMU walls, surface mounted fixtures, poor condition

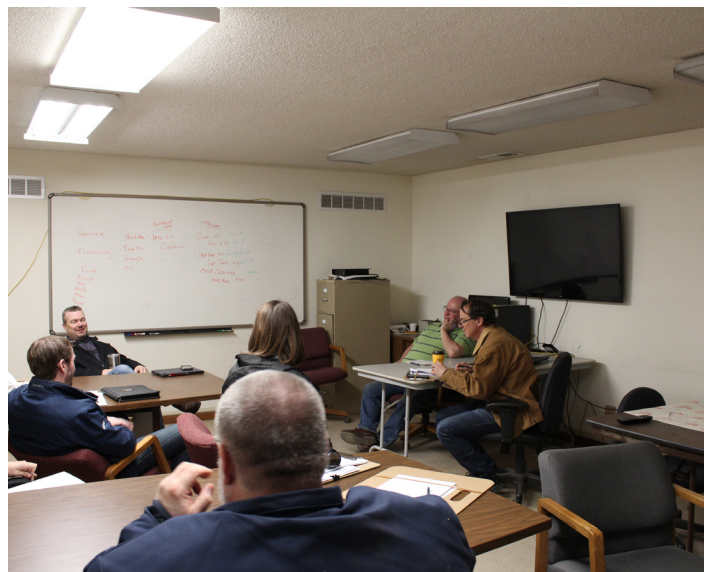
Linoleum floor, painted gypsum board walls, popcorn ceiling, surface mounted fixtures

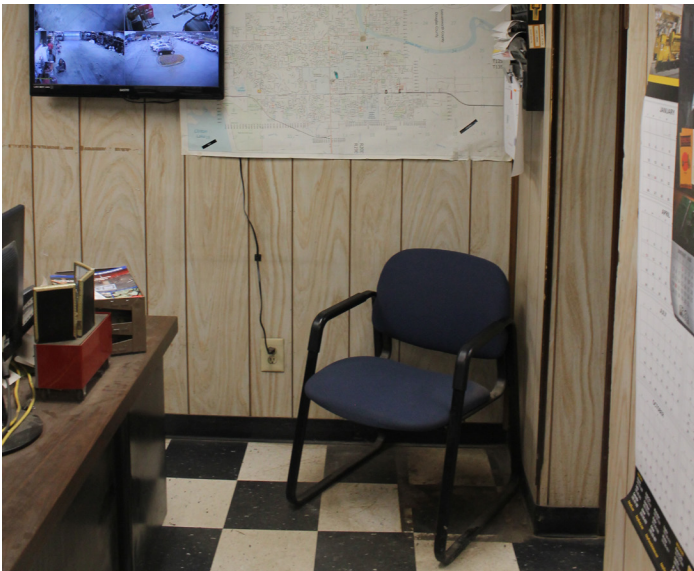
Linoleum tile floor decorative wall covering, poor condition

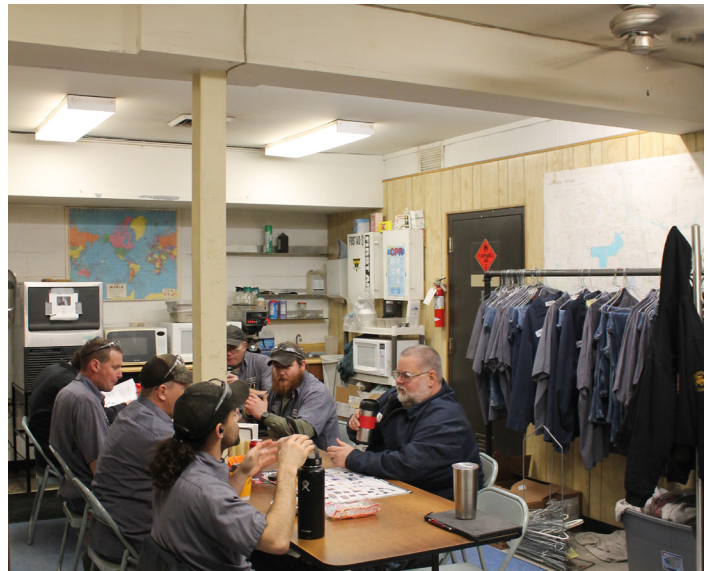
Linoleum tile floor, decorative wall covering, gypsum board ceiling, surface mounted fixtures, poor condition

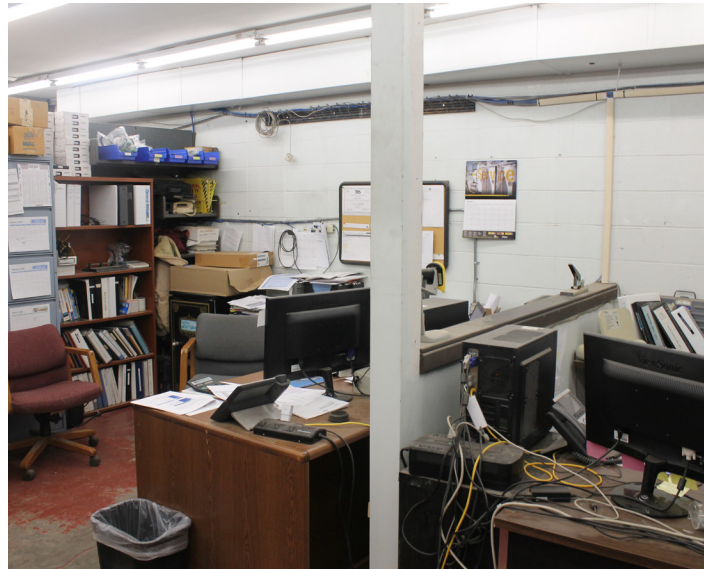
Concrete floor, painted CMU walls, gyp board ceiling, surface mounted fixtures, poor condition

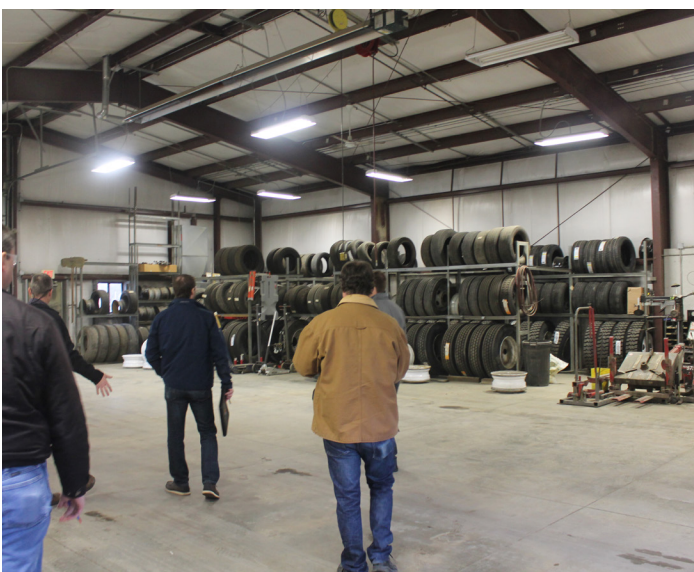
Concrete floor, pre-engineered steel structure; good condition

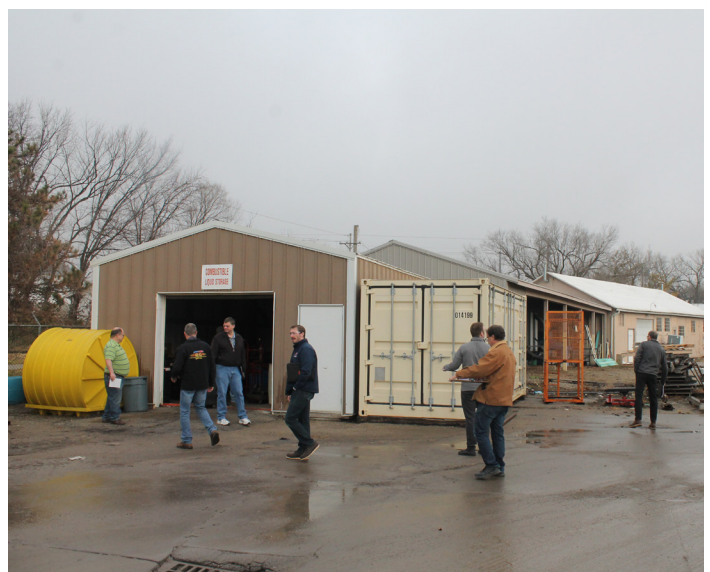
Exterior storage shed, good condition

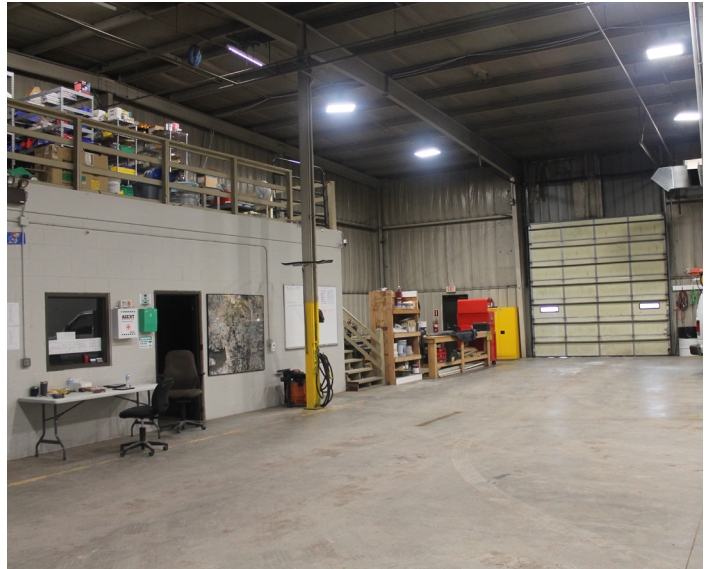
Concrete floor, exposed pre-engineered steel structure, poor condition

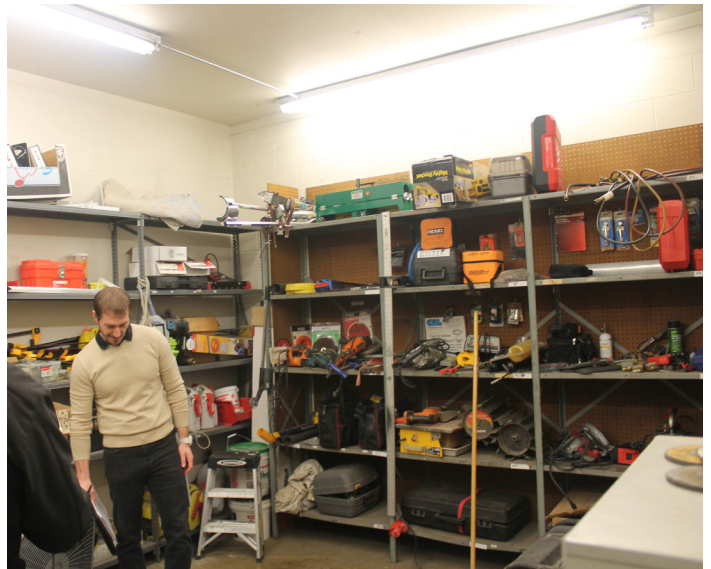
Concrete floor, painted gypsum board walls and ceiling, surface mounted lights

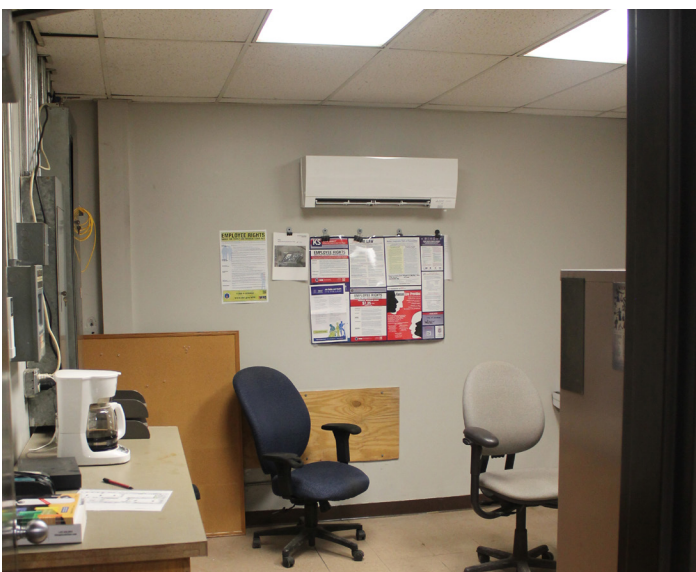
Linoleum floor, 2'x4' ACT ceiling, poor condition

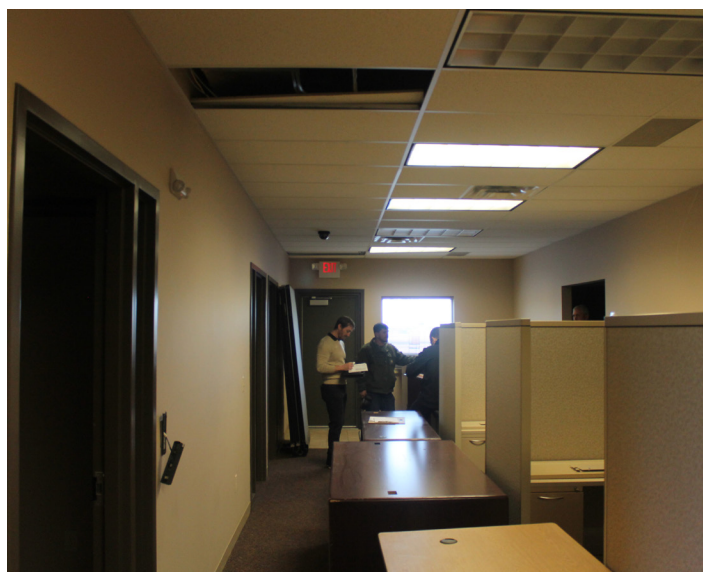
Carpet floor, ACT ceiling with lights

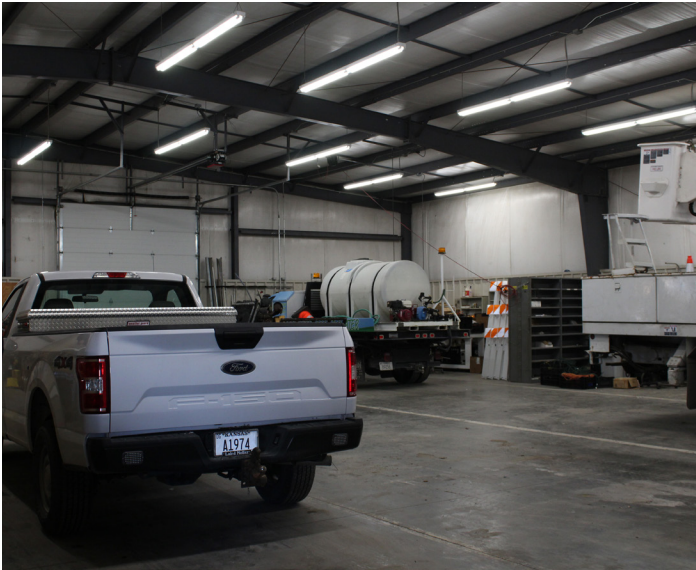
Concrete floor, pre-engineered metal structure, good condition

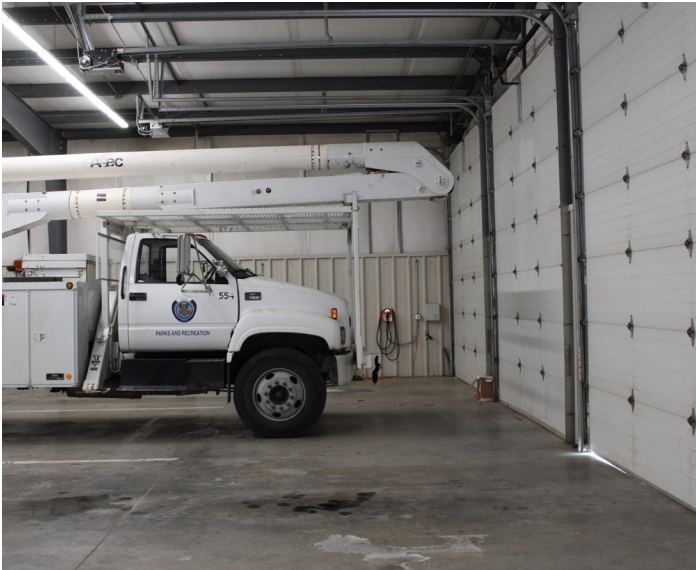
Concrete floor, pre-engineered metal structure, good condition

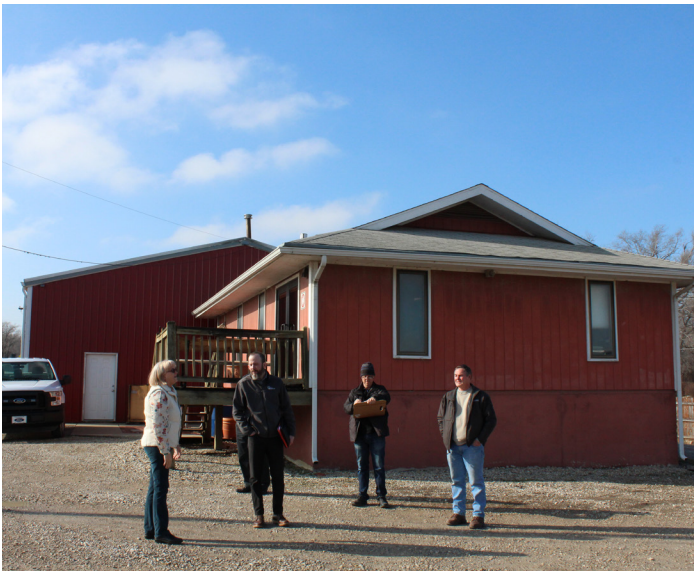
Exterior - fair condition

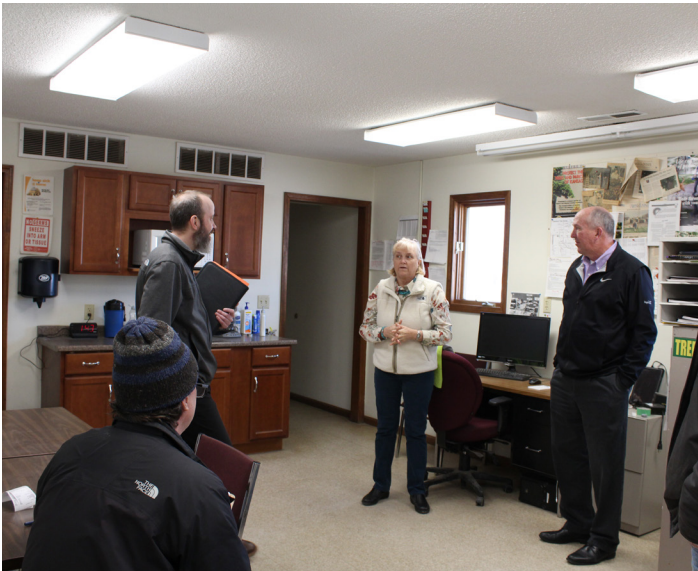
Linoleum flooring, painted gypsum board walls, popcorn ceiling, surface mounted fixtures

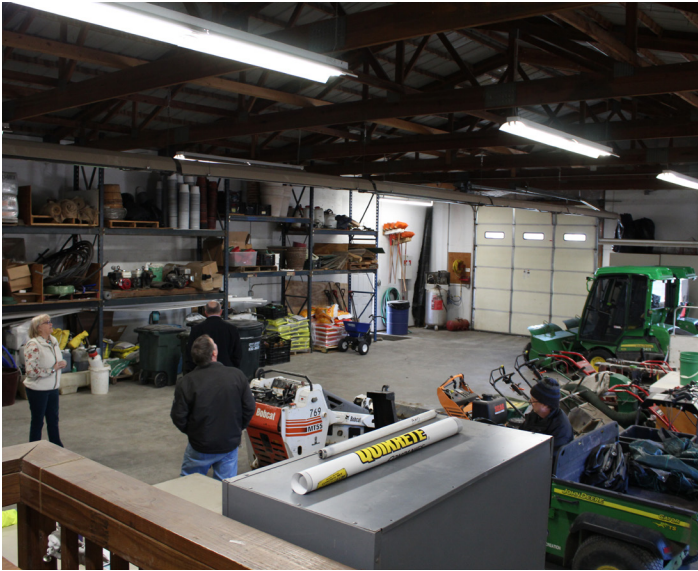
Concrete floor, pre-engineered metal structure, good condition

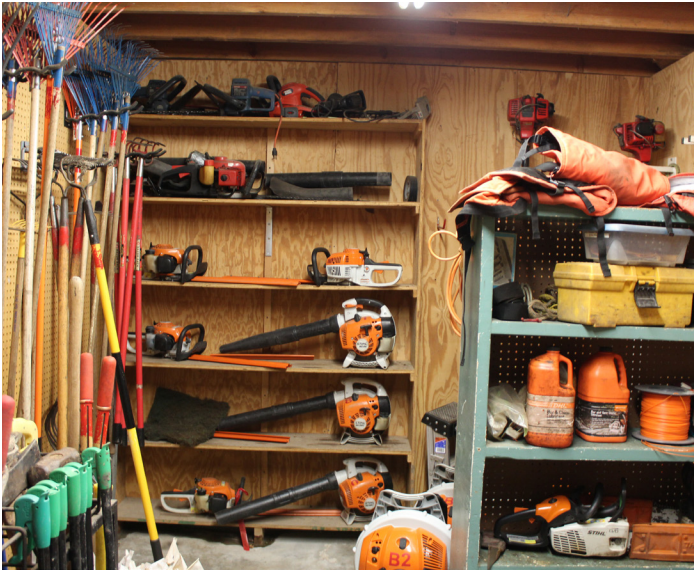
Concrete floor, plywood walls, good condition

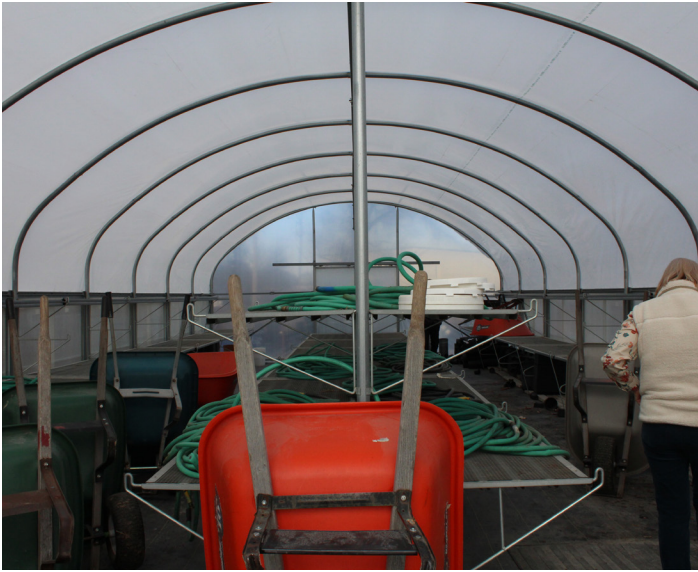
Prefabricated greenhouse structure, good condition

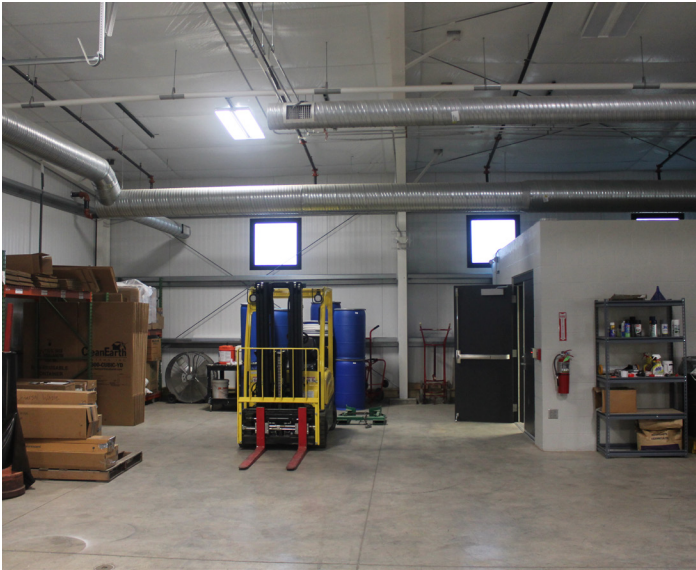
Concrete floor, pre-engineered steel structure, bag insulation, good condition

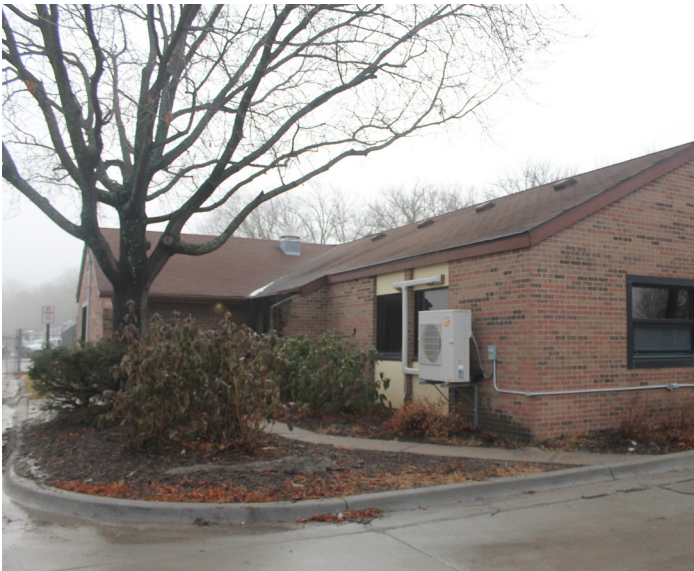
Exterior - good condition

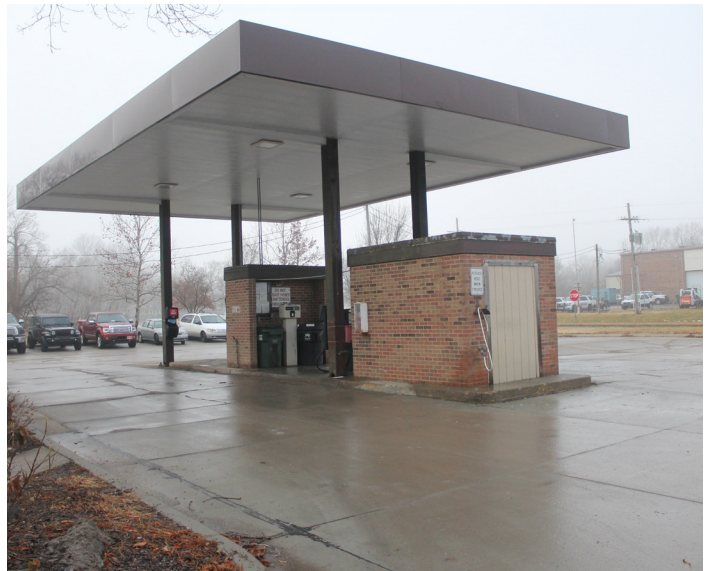
Fueling station, good condition

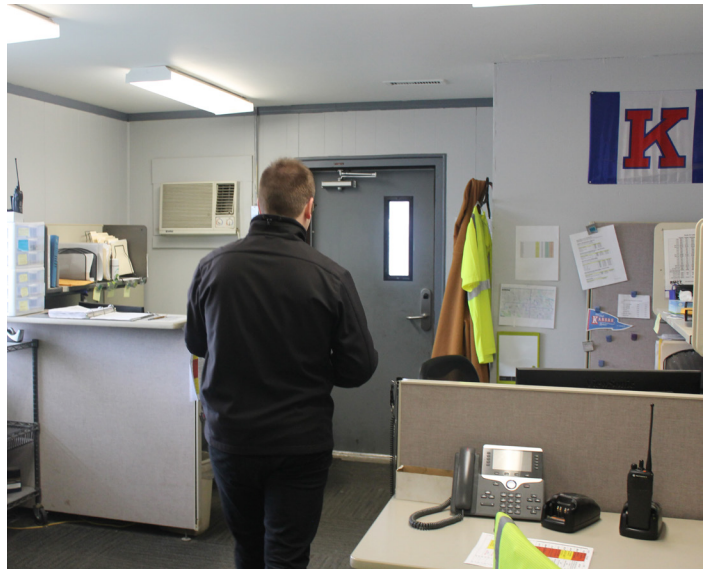
Carpet tile flooring, painted CMU walls, gypsum board ceiling, surface mounted fixtures, poor condition

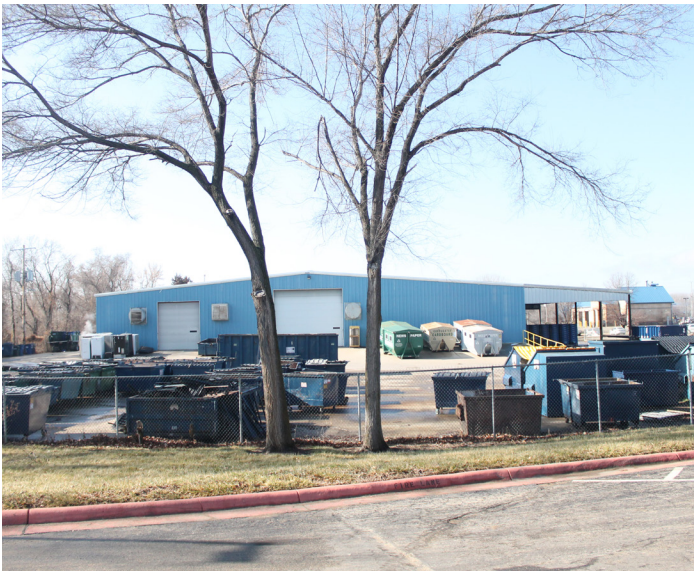
Solid Waste - exterior, good condition

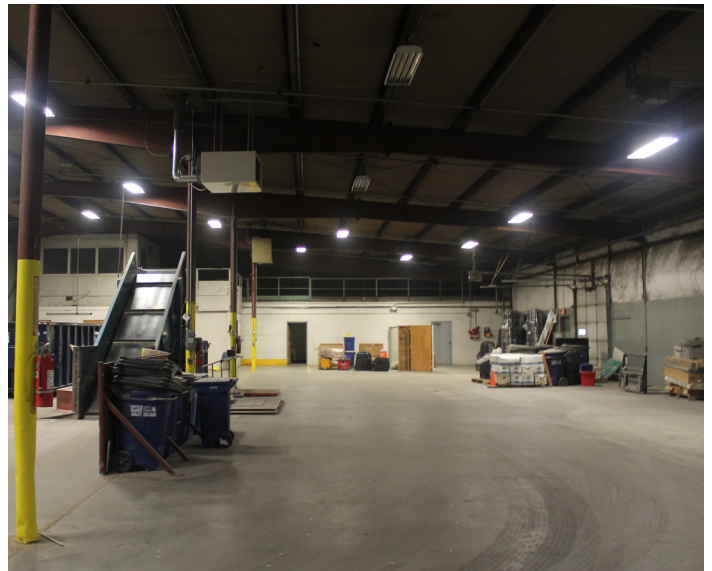
Concrete floor, pre-engineered steel structure, good condition

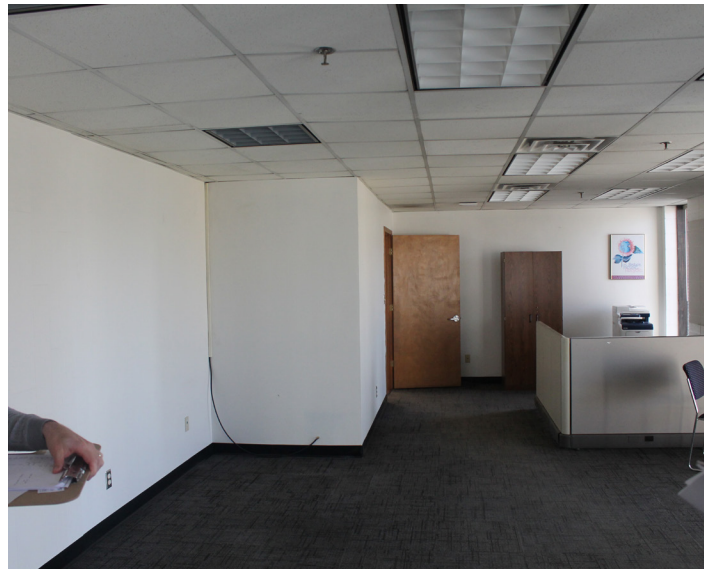
Carpet tile floors, gypsum board walls, ACT tile ceiling, fair condition

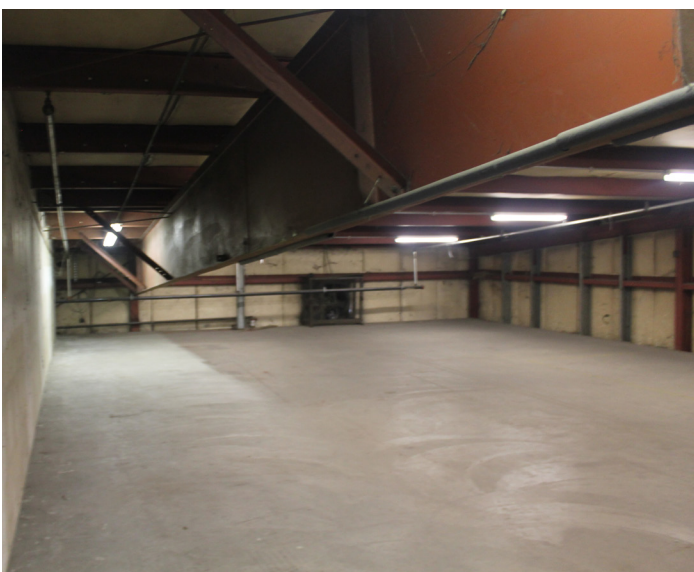
Concrete floors, pre-engineered steel structure, fair

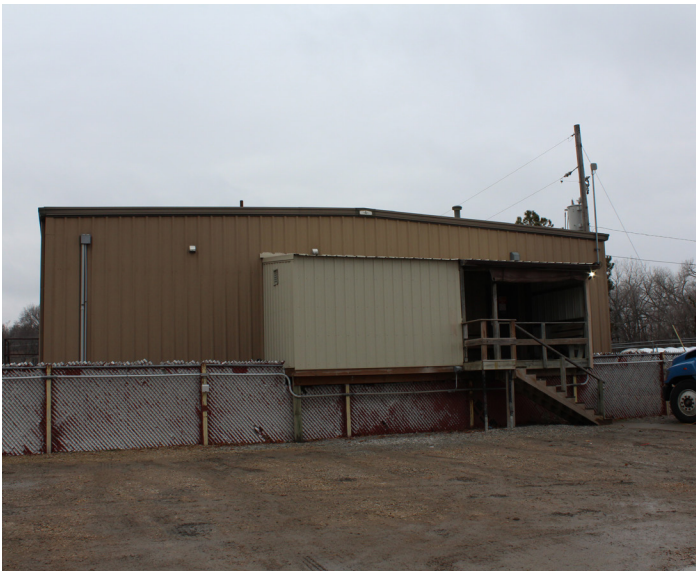
Exterior - poor condition

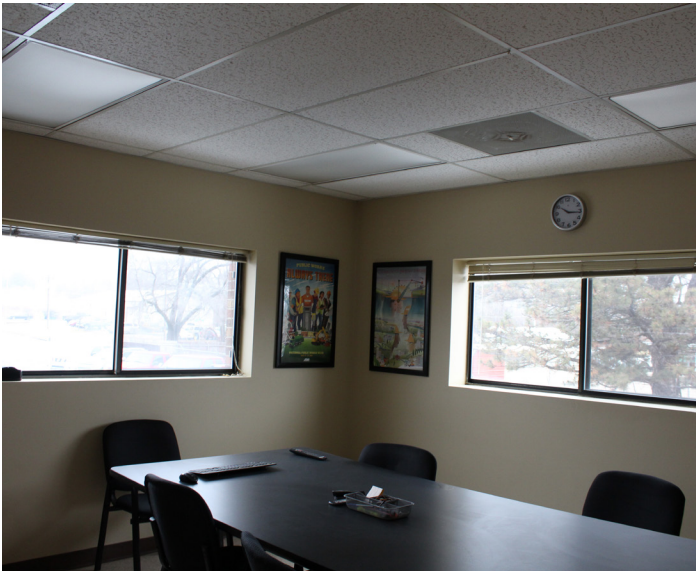
Linoleum flooring, painted gypsum board walls, ACT ceiling, good condition

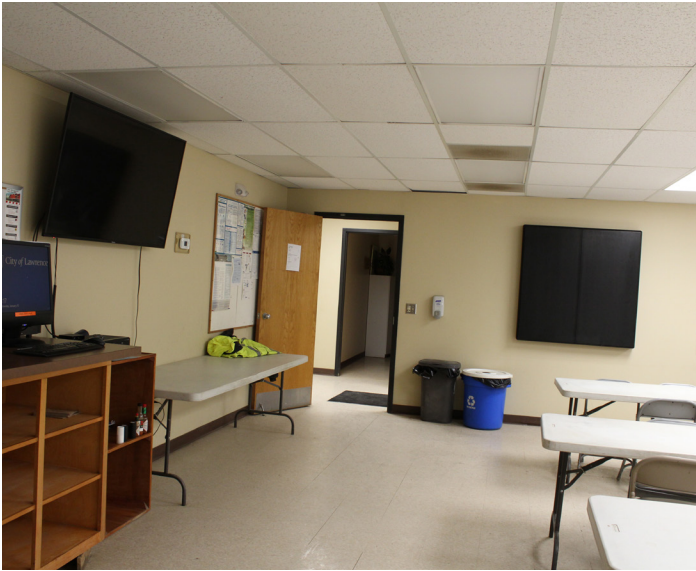
Linoleum flooring, painted gypsum board walls, ACT ceiling, poor condition

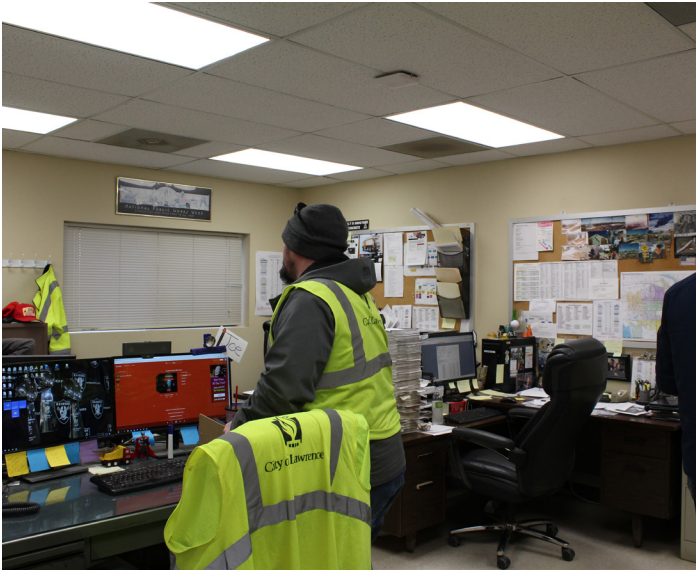
Linoleum flooring, painted gypsum board walls, ACT ceiling, poor condition

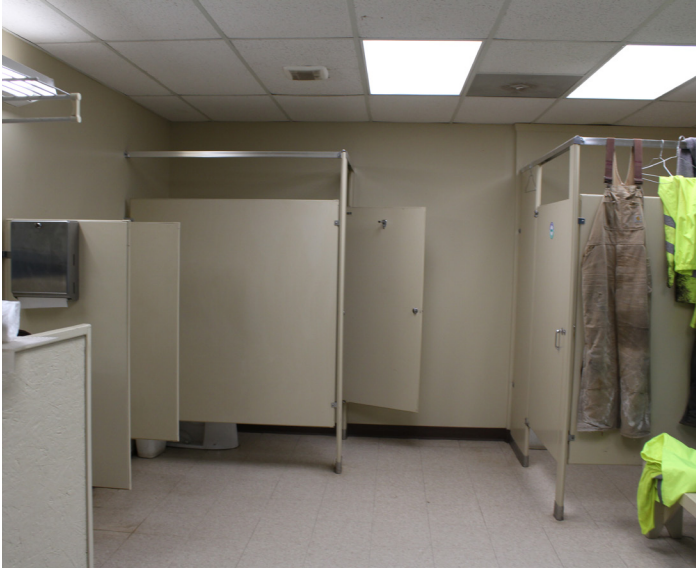
Linoleum flooring, painted gypsum board walls, ACT ceiling, poor condition

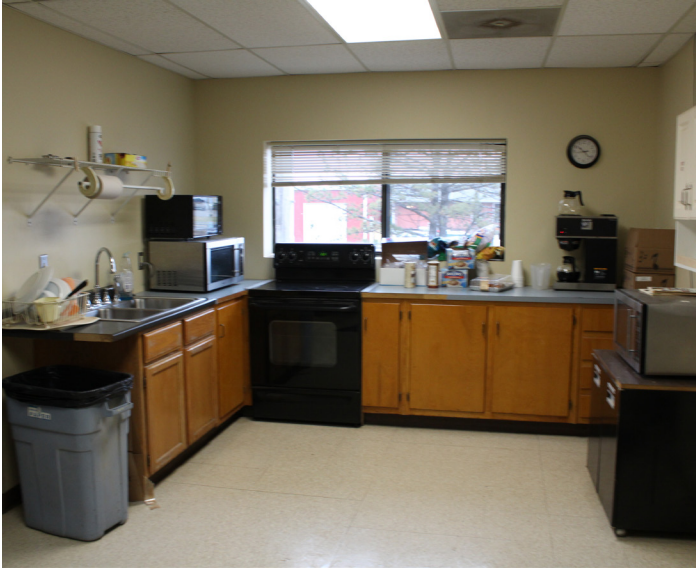
Linoleum flooring, painted gypsum board walls, ACT ceiling, poor condition

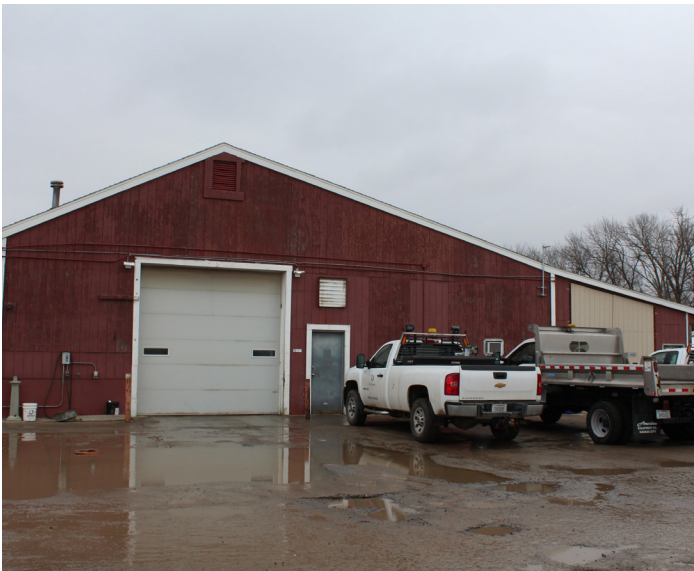
Exterior - poor condition

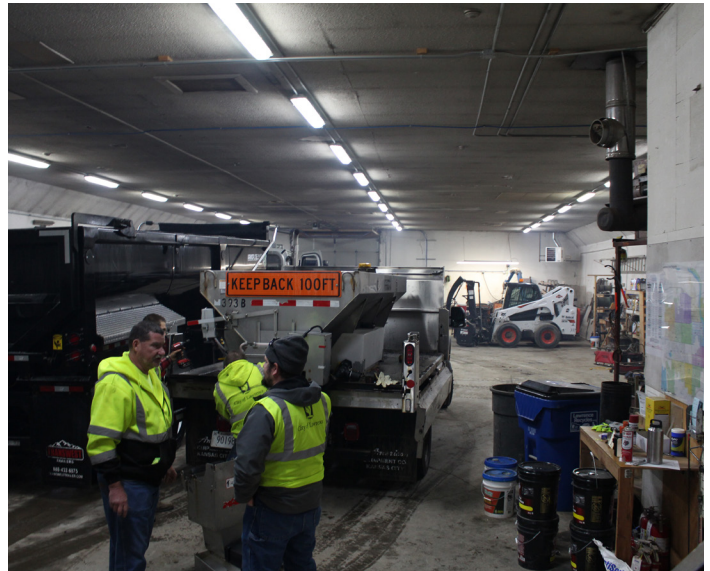
Concrete floor, surface mounted fixtures, overall poor condition

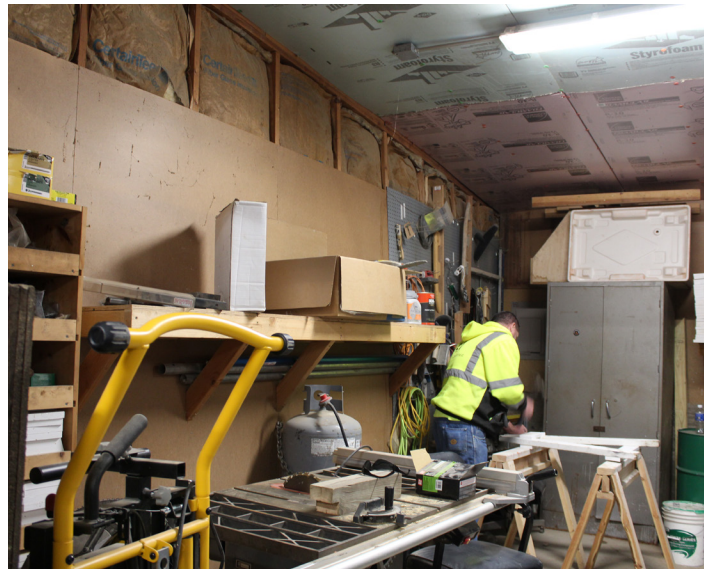
Concrete floor, exposed insulation, surface mounted fixtures, overall poor condition

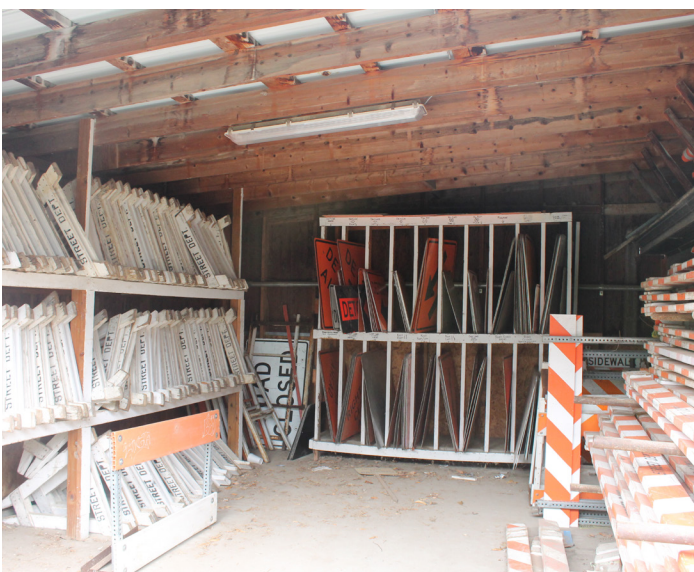
Learn-to structure, surface mounted fixture, good condition

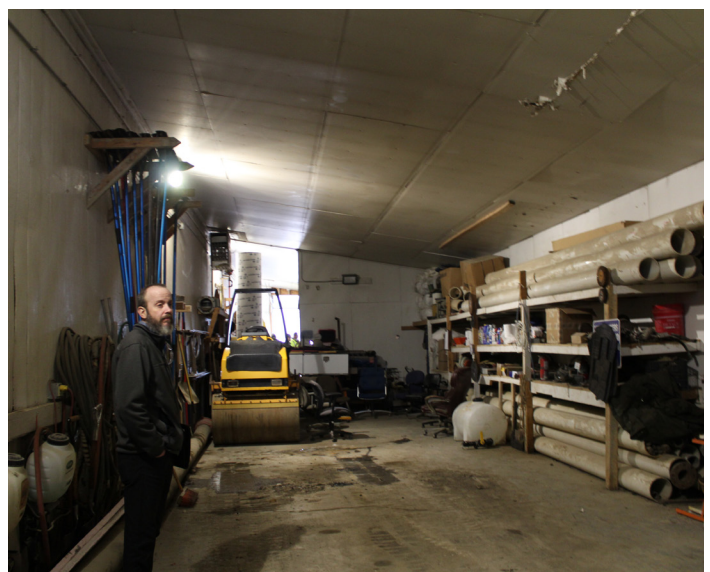
Concrete floor, ceiling damage, overall poor condition

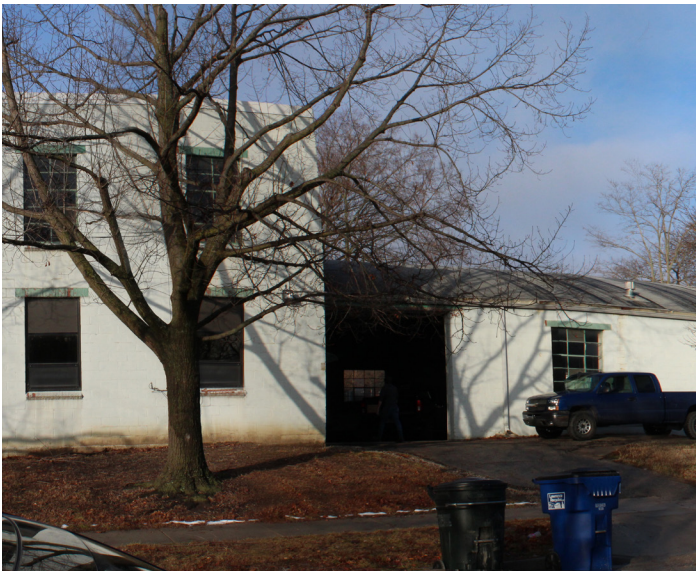
Exterior - poor condition

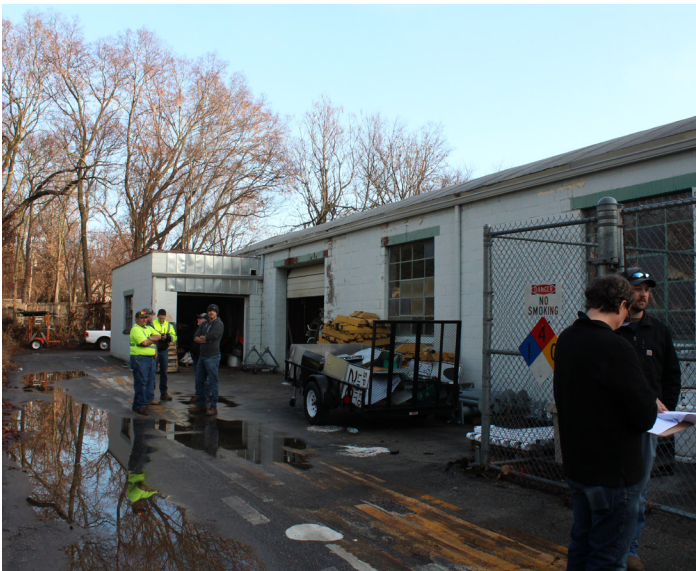
Exterior - poor condition

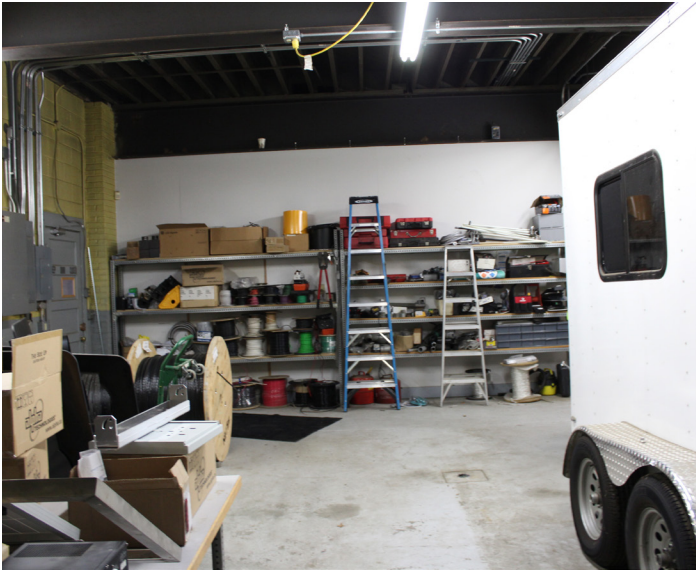
Concrete floor, painted CMU and gypsum board walls, fair condition

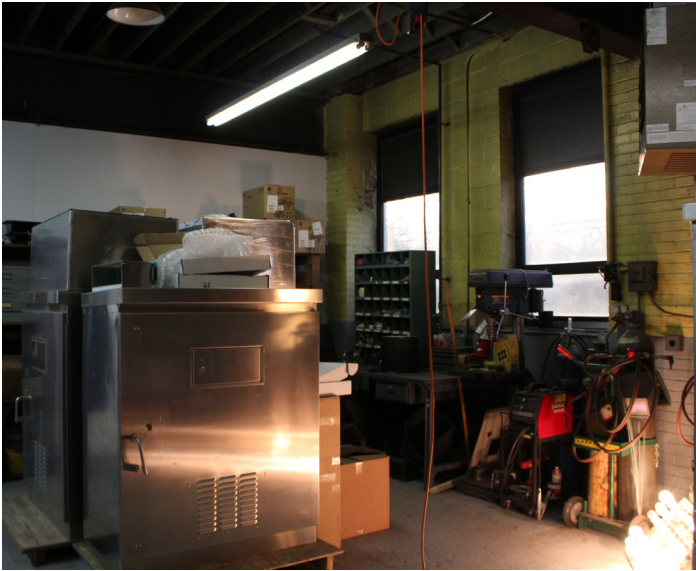
Concrete floor, painted CMU and gypsum board walls, fair condition

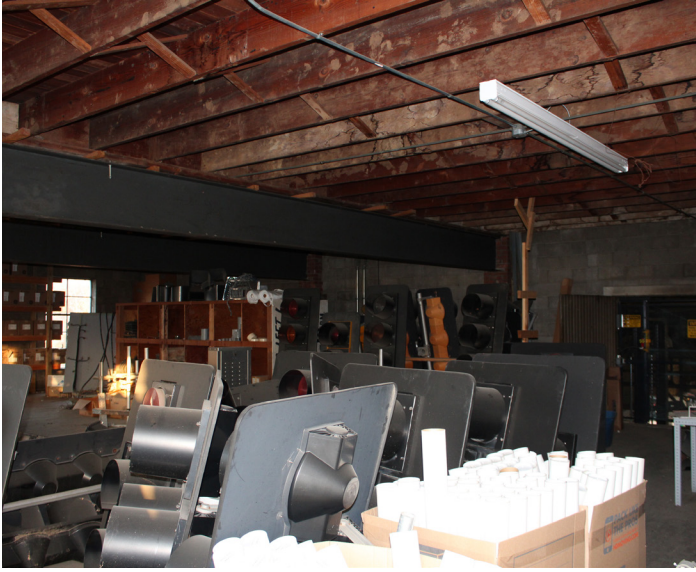
Concrete floor, CMU walls, exposed structure, fair condition

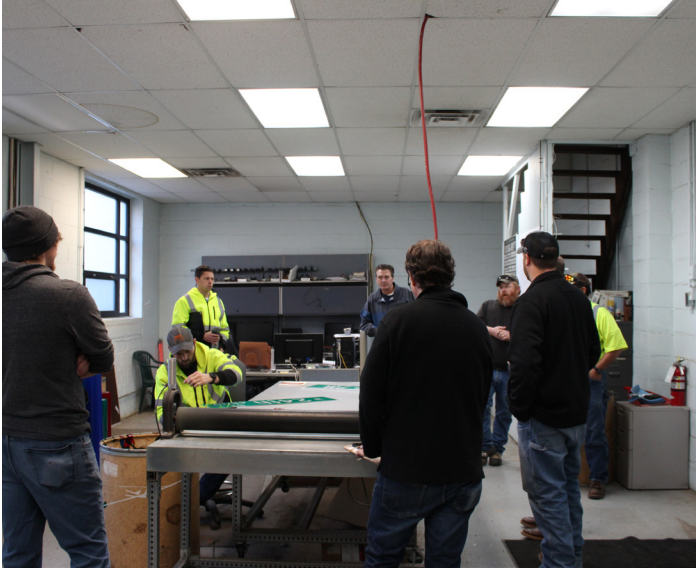
Concrete floor, painted CMU walls, ACT ceiling, fair condition

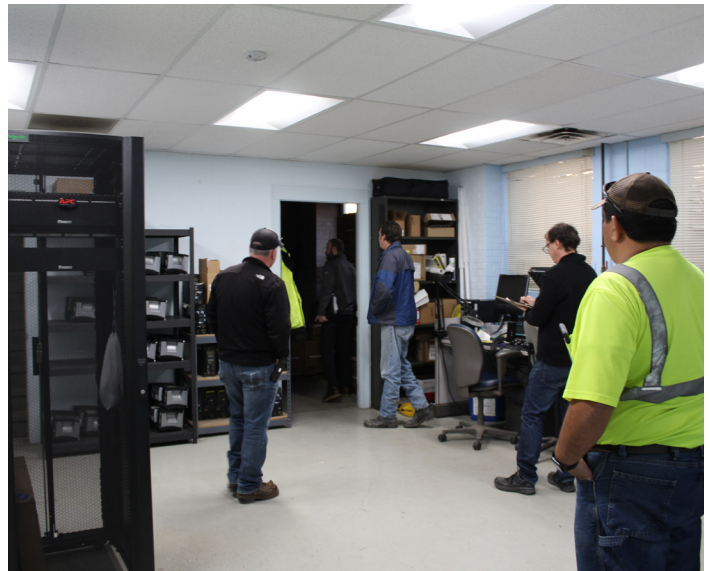
Linoleum flooring, painted CMU walls, ACT ceiling, fair condition

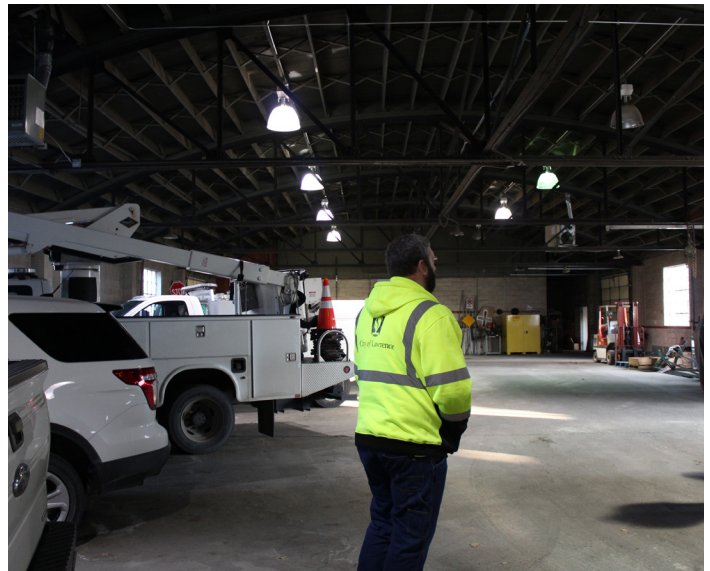
Concrete floor, CMU walls, exposed structure

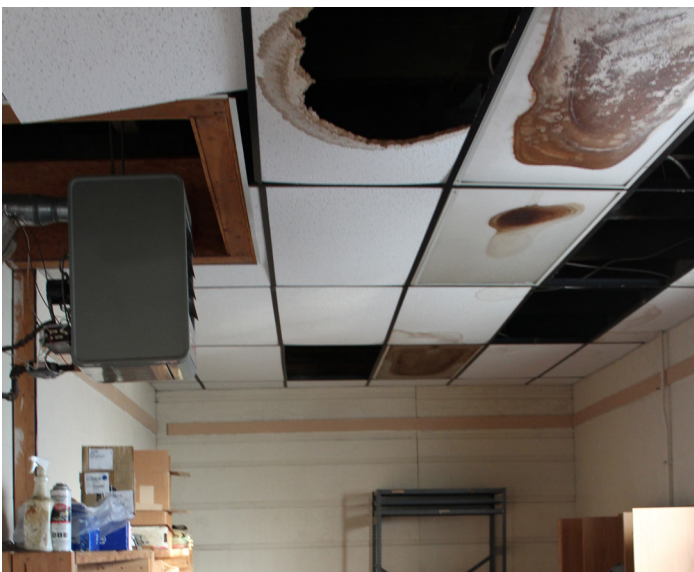
Water damage, poor condition

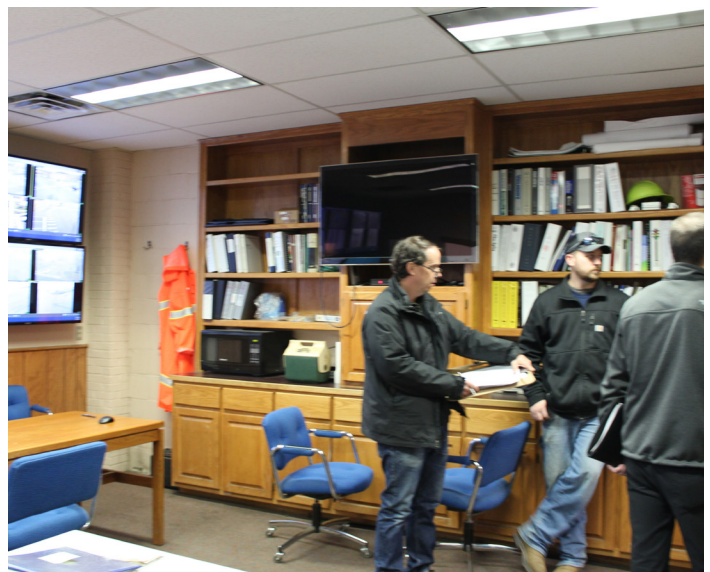
Linoleum flooring, painted CMU walls built in storage, ACT ceiling, poor condition

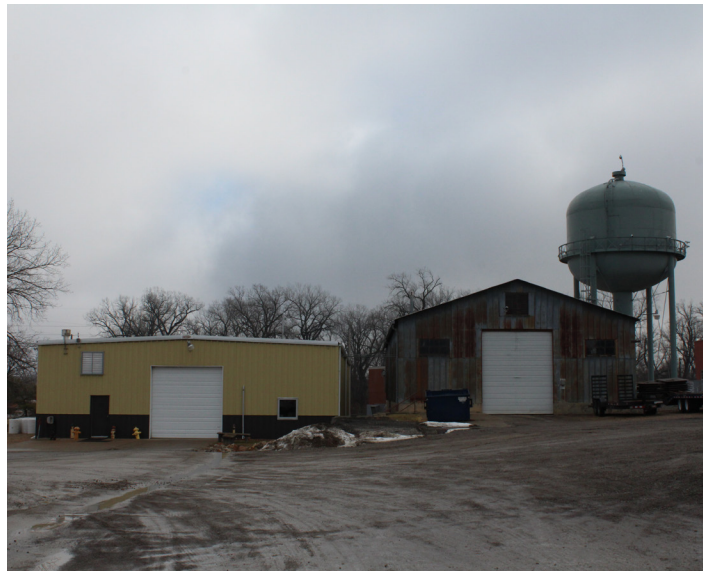
Exterior - fair condition (left) poor condition (right)

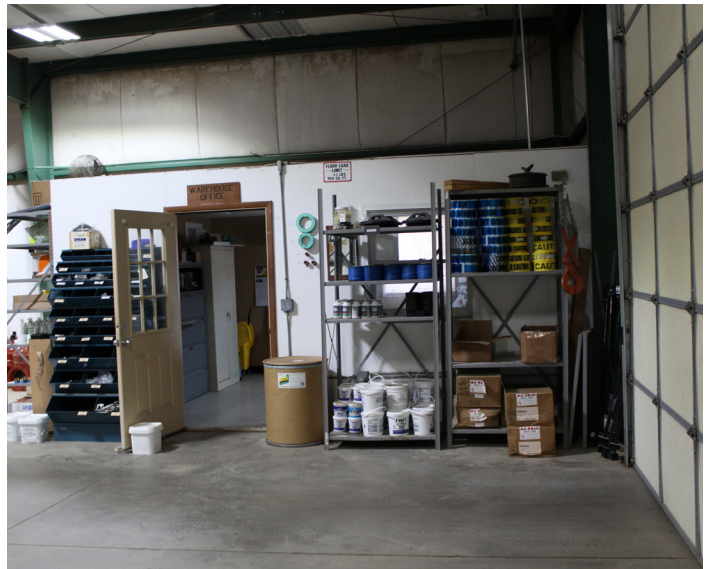
Concrete floor, damaged insulation, fair condition

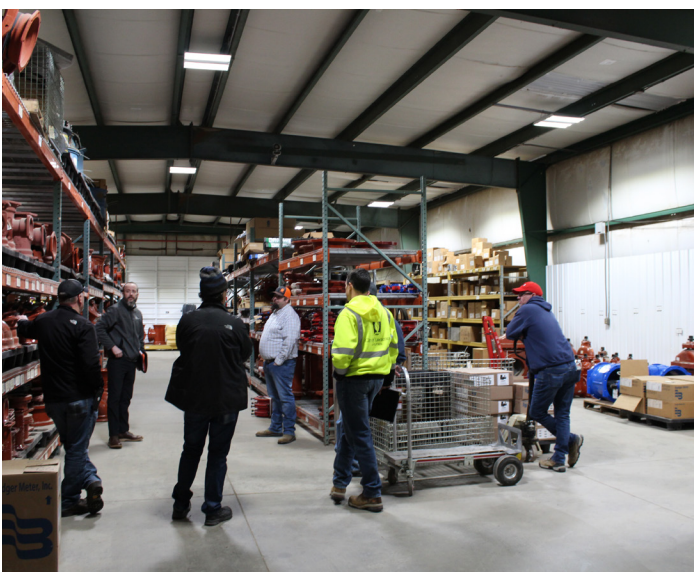
Concrete floor, pre-engineered steel structure, bag insulation, fair condition

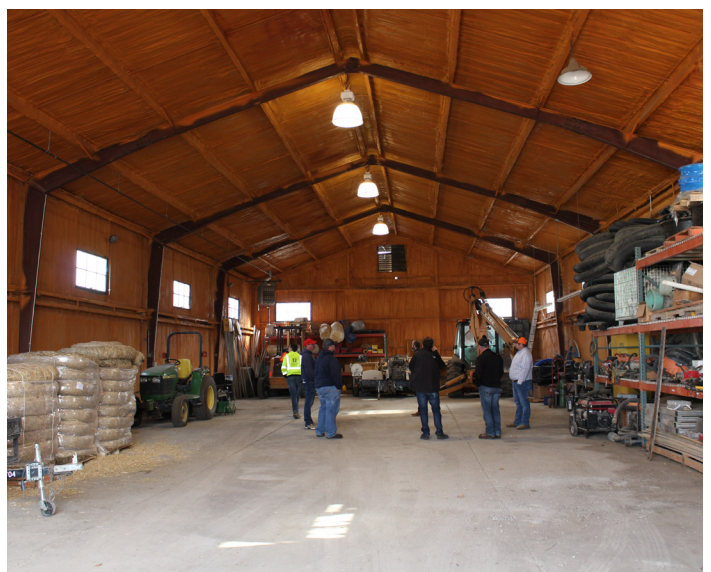
Concrete floor, pre-engineered steel structure, pendant lights, overall good condition
