City of Lawrence

# Lawrence Field Operations Facility

## Existing Facility Condition Narratives

DAKE | WELLS  
architecture

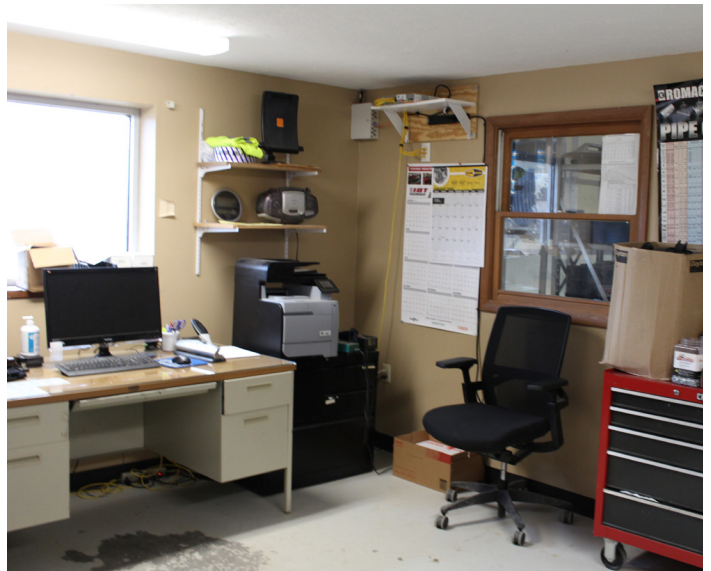
Concrete floor, painted gypsum board walls, ACT ceiling, poor condition

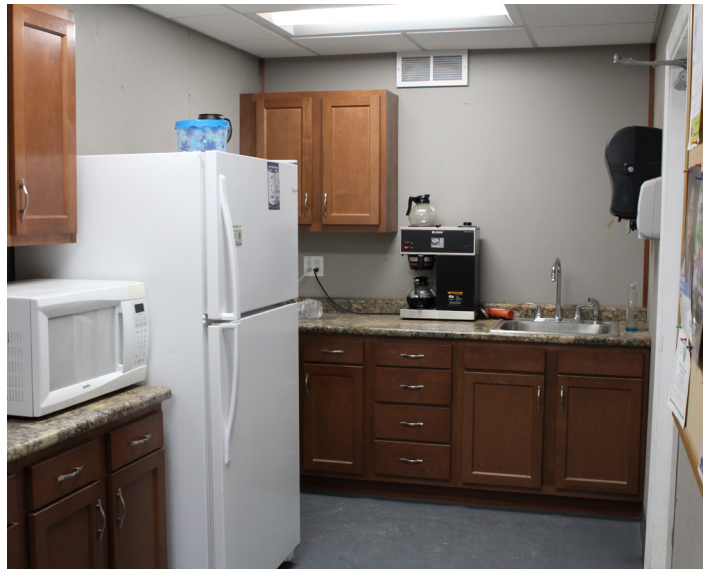
Linoleum flooring, painted gypsum board walls, ACT ceiling, good condition

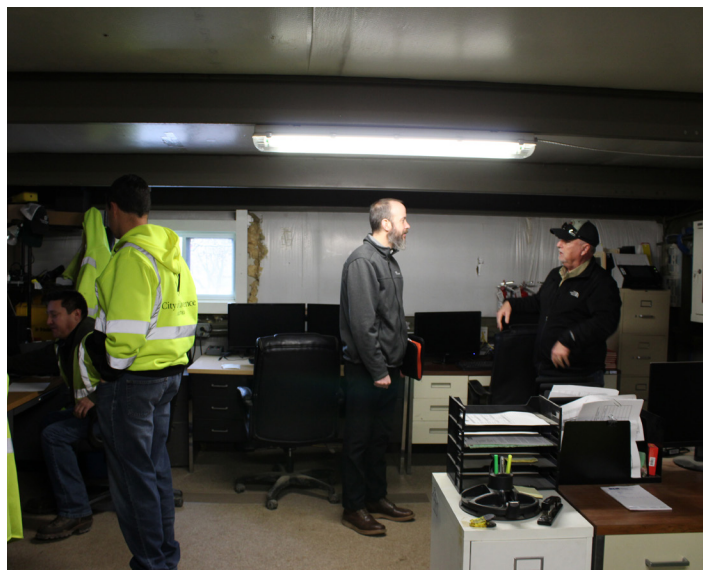
Concrete floor, steel structure, bag insulation, surface mounted fixtures, overall poor condition
