Data Gap Study Report

Former Farmland Industries Nitrogen Plant
1608 North 1400 Road
Lawrence, Kansas 66046

City of Lawrence, Kansas

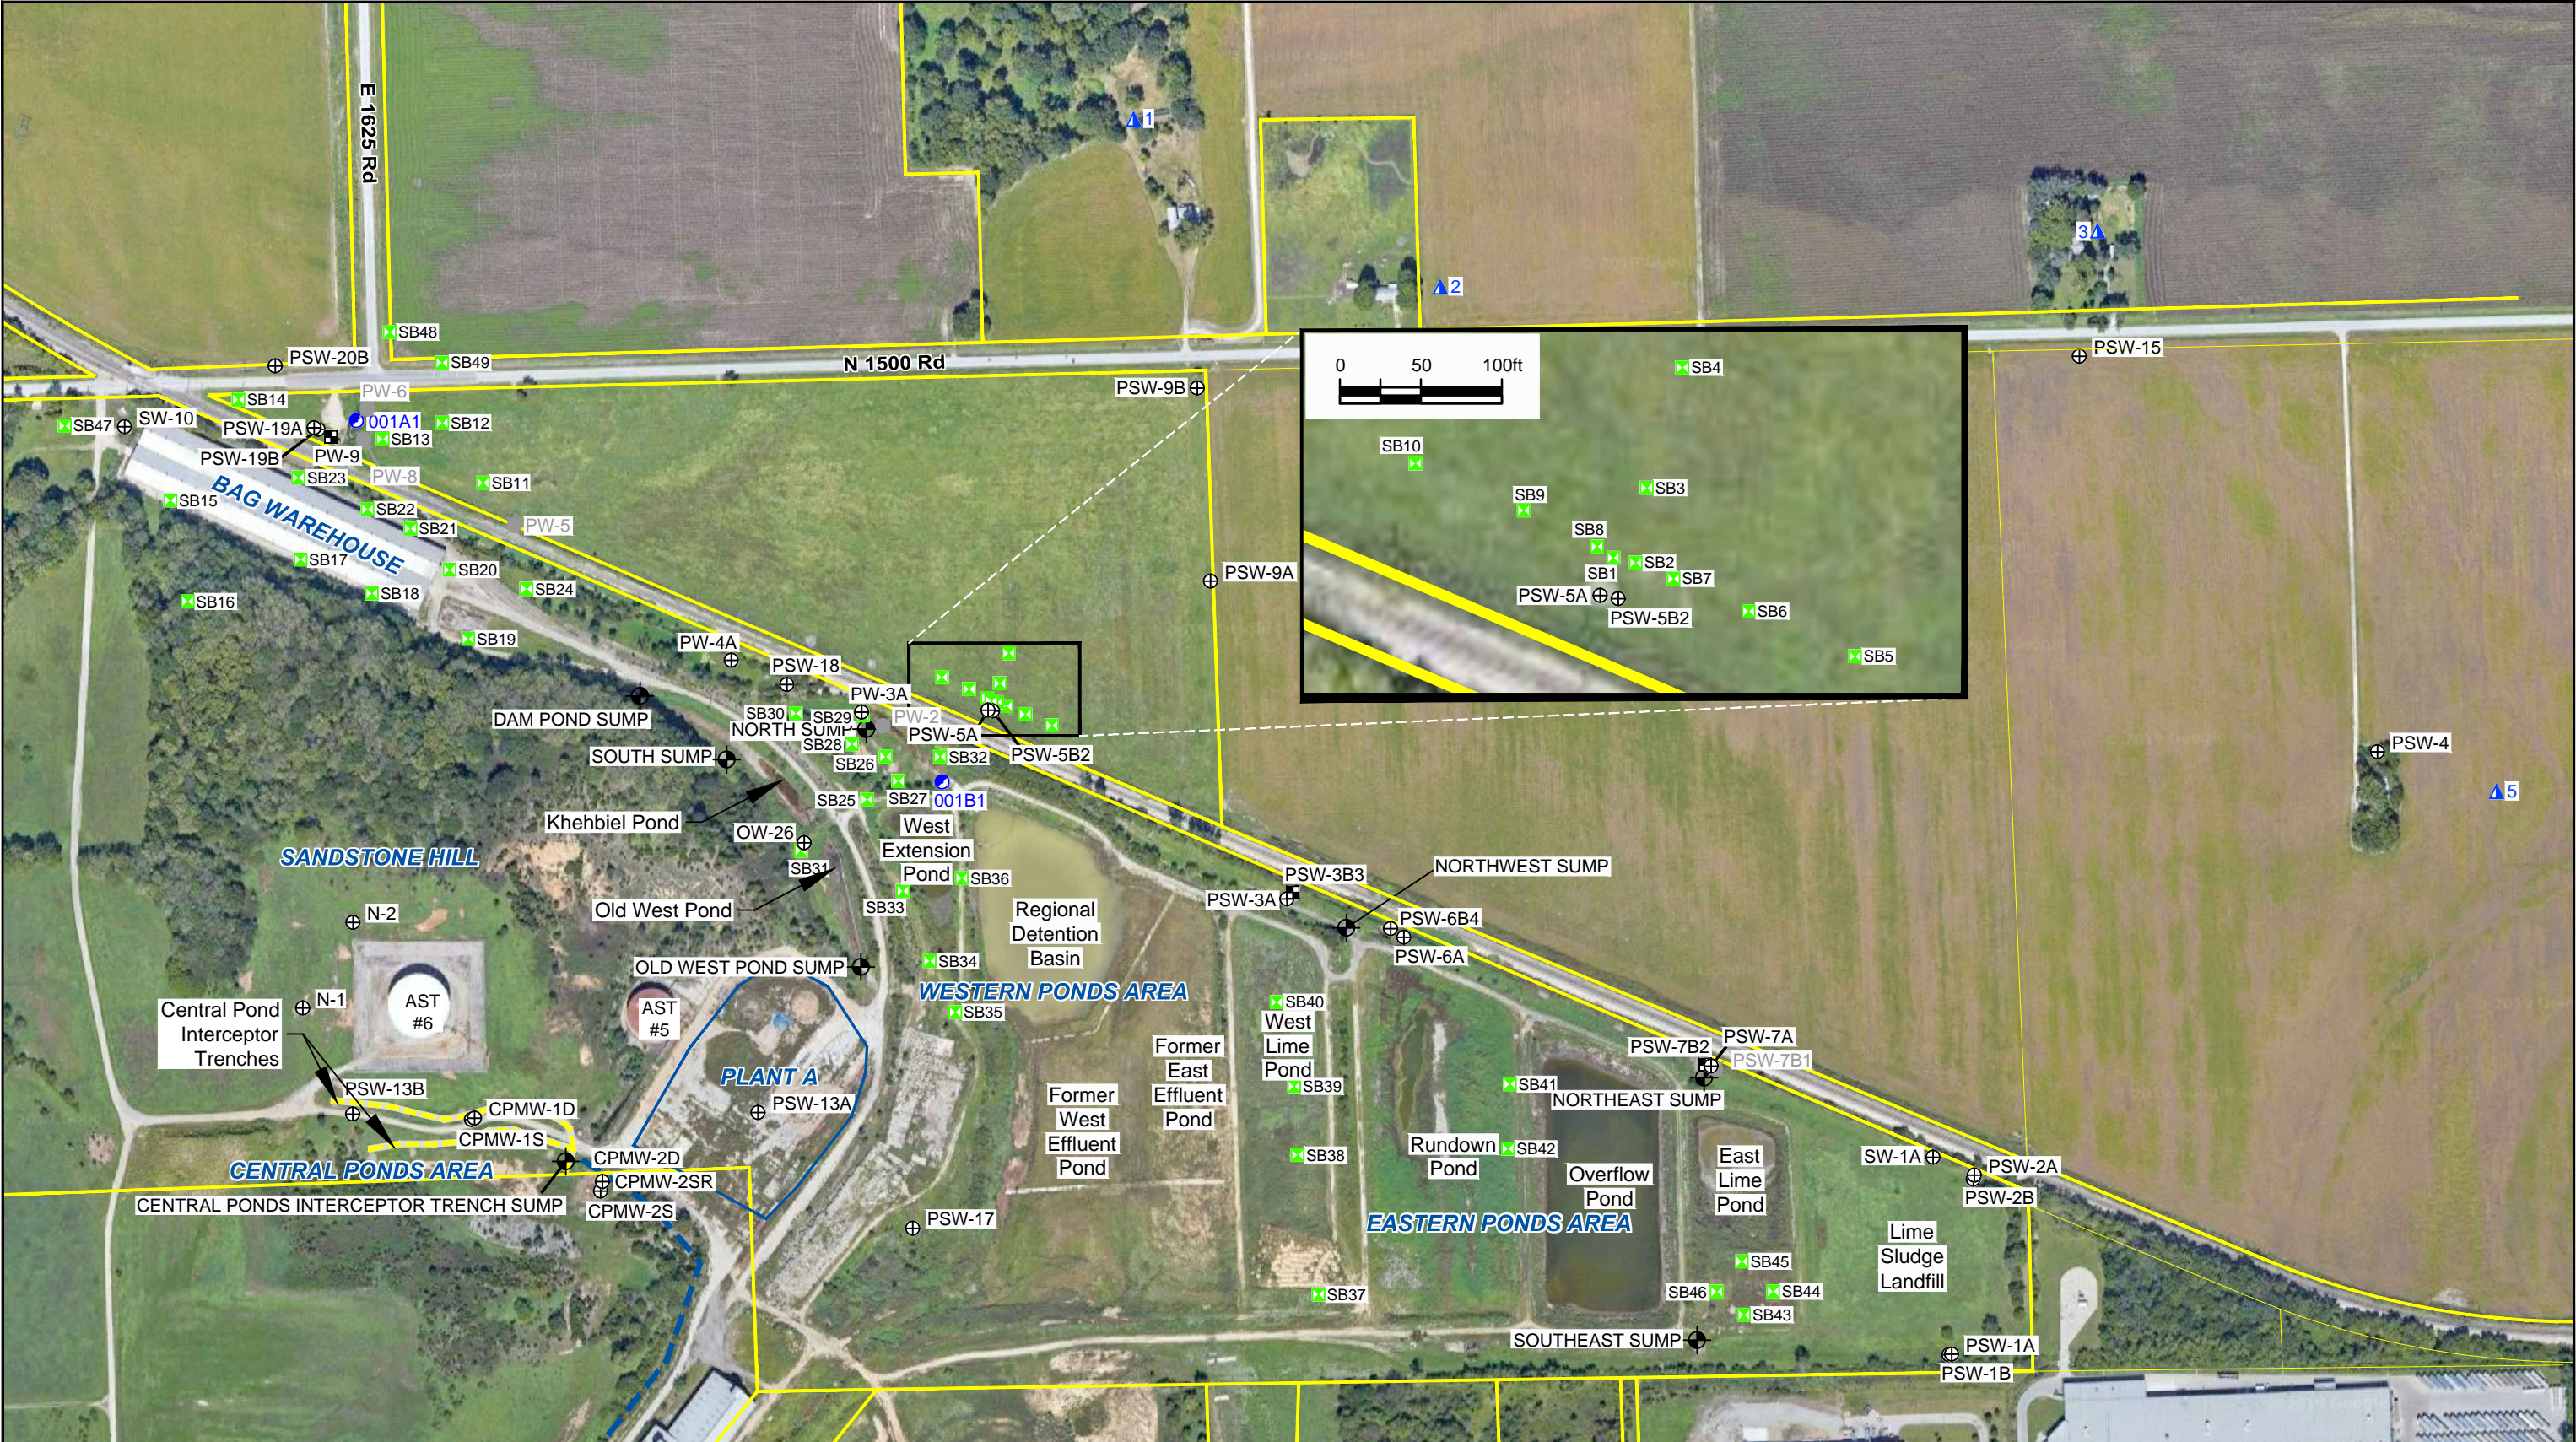
FIGURE 2

During the DGS work planning and field implementation phase, sampling soil and groundwater within the Overflow Pond was inaccessible. The Site layout and the direct push boring locations are shown on Figure 2.

GHD advanced 49 direct-push borings at the locations shown on Figure 2. Borings were advanced to a maximum depth of 70 feet below ground surface (bgs), or until competent bedrock refusal was met. The depth was also guided by field screening nitrate results. A GHD representative, under the supervision of a Kansas-licensed geologist, examined and classified recovered unsaturated soil samples in the field in accordance with the Unified Soil Classification System (USCS). Stratigraphic boring logs are found in Appendix B. Field documentation is found in Appendix C.

SITE LAYOUT - DGS SOIL BORING LOCATIONS

Tonganoxie Sandstone is an interbedded sandstone that consists of sandstone, shale and limestone. The sandstone represents a prominent topographic high feature known as Sandstone Hill (see Figure 2) where several nitrogen processes occurred. The sandstone is partially saturated and can exist under unconfined or confined conditions. Given its interbedded nature, the permeability is variable with the interbedded shale units acting as aquitards. Groundwater flow is radially from the Sandstone Hill and controlled by fractures. On the north end of the Site, the sandstone groundwater discharges into the alluvial aquifer, which abuts up against the sandstone.

As noted in Table 4.1, the capture width generated by the four extraction wells ranged from 170 to 510 feet. PSW-3B3 and PSW-6B4 are approximately 300 feet apart. While PSW-7B2 is approximately 850 feet east from PSW-6B4 (see Figure 2), These capture widths indicate that PSW-3B3 and PSW-6B4 would interact with each other as a single well type system to create a large capture zone. However, there is very likely a flow gap between PSW-7B2 and the other two extraction wells because of the distance between them is greater than the combined predicted capture widths. This flow gap may be a moot point, however, because these wells do not capture elevated levels of nitrate or ammonia.

The Sandstone Hill Area has identified nitrate and ammonia impacts attributed to the UAN ponds formerly located on top of the Sandstone Hill (see Figure 2 for location of Sandstone Hill). Nitrate and ammonia leached downward into the fractured shale and sandstone. The nitrogen impacts were further mobilized by surface infiltration of precipitation and groundwater flowing underneath the hill from the southwest.

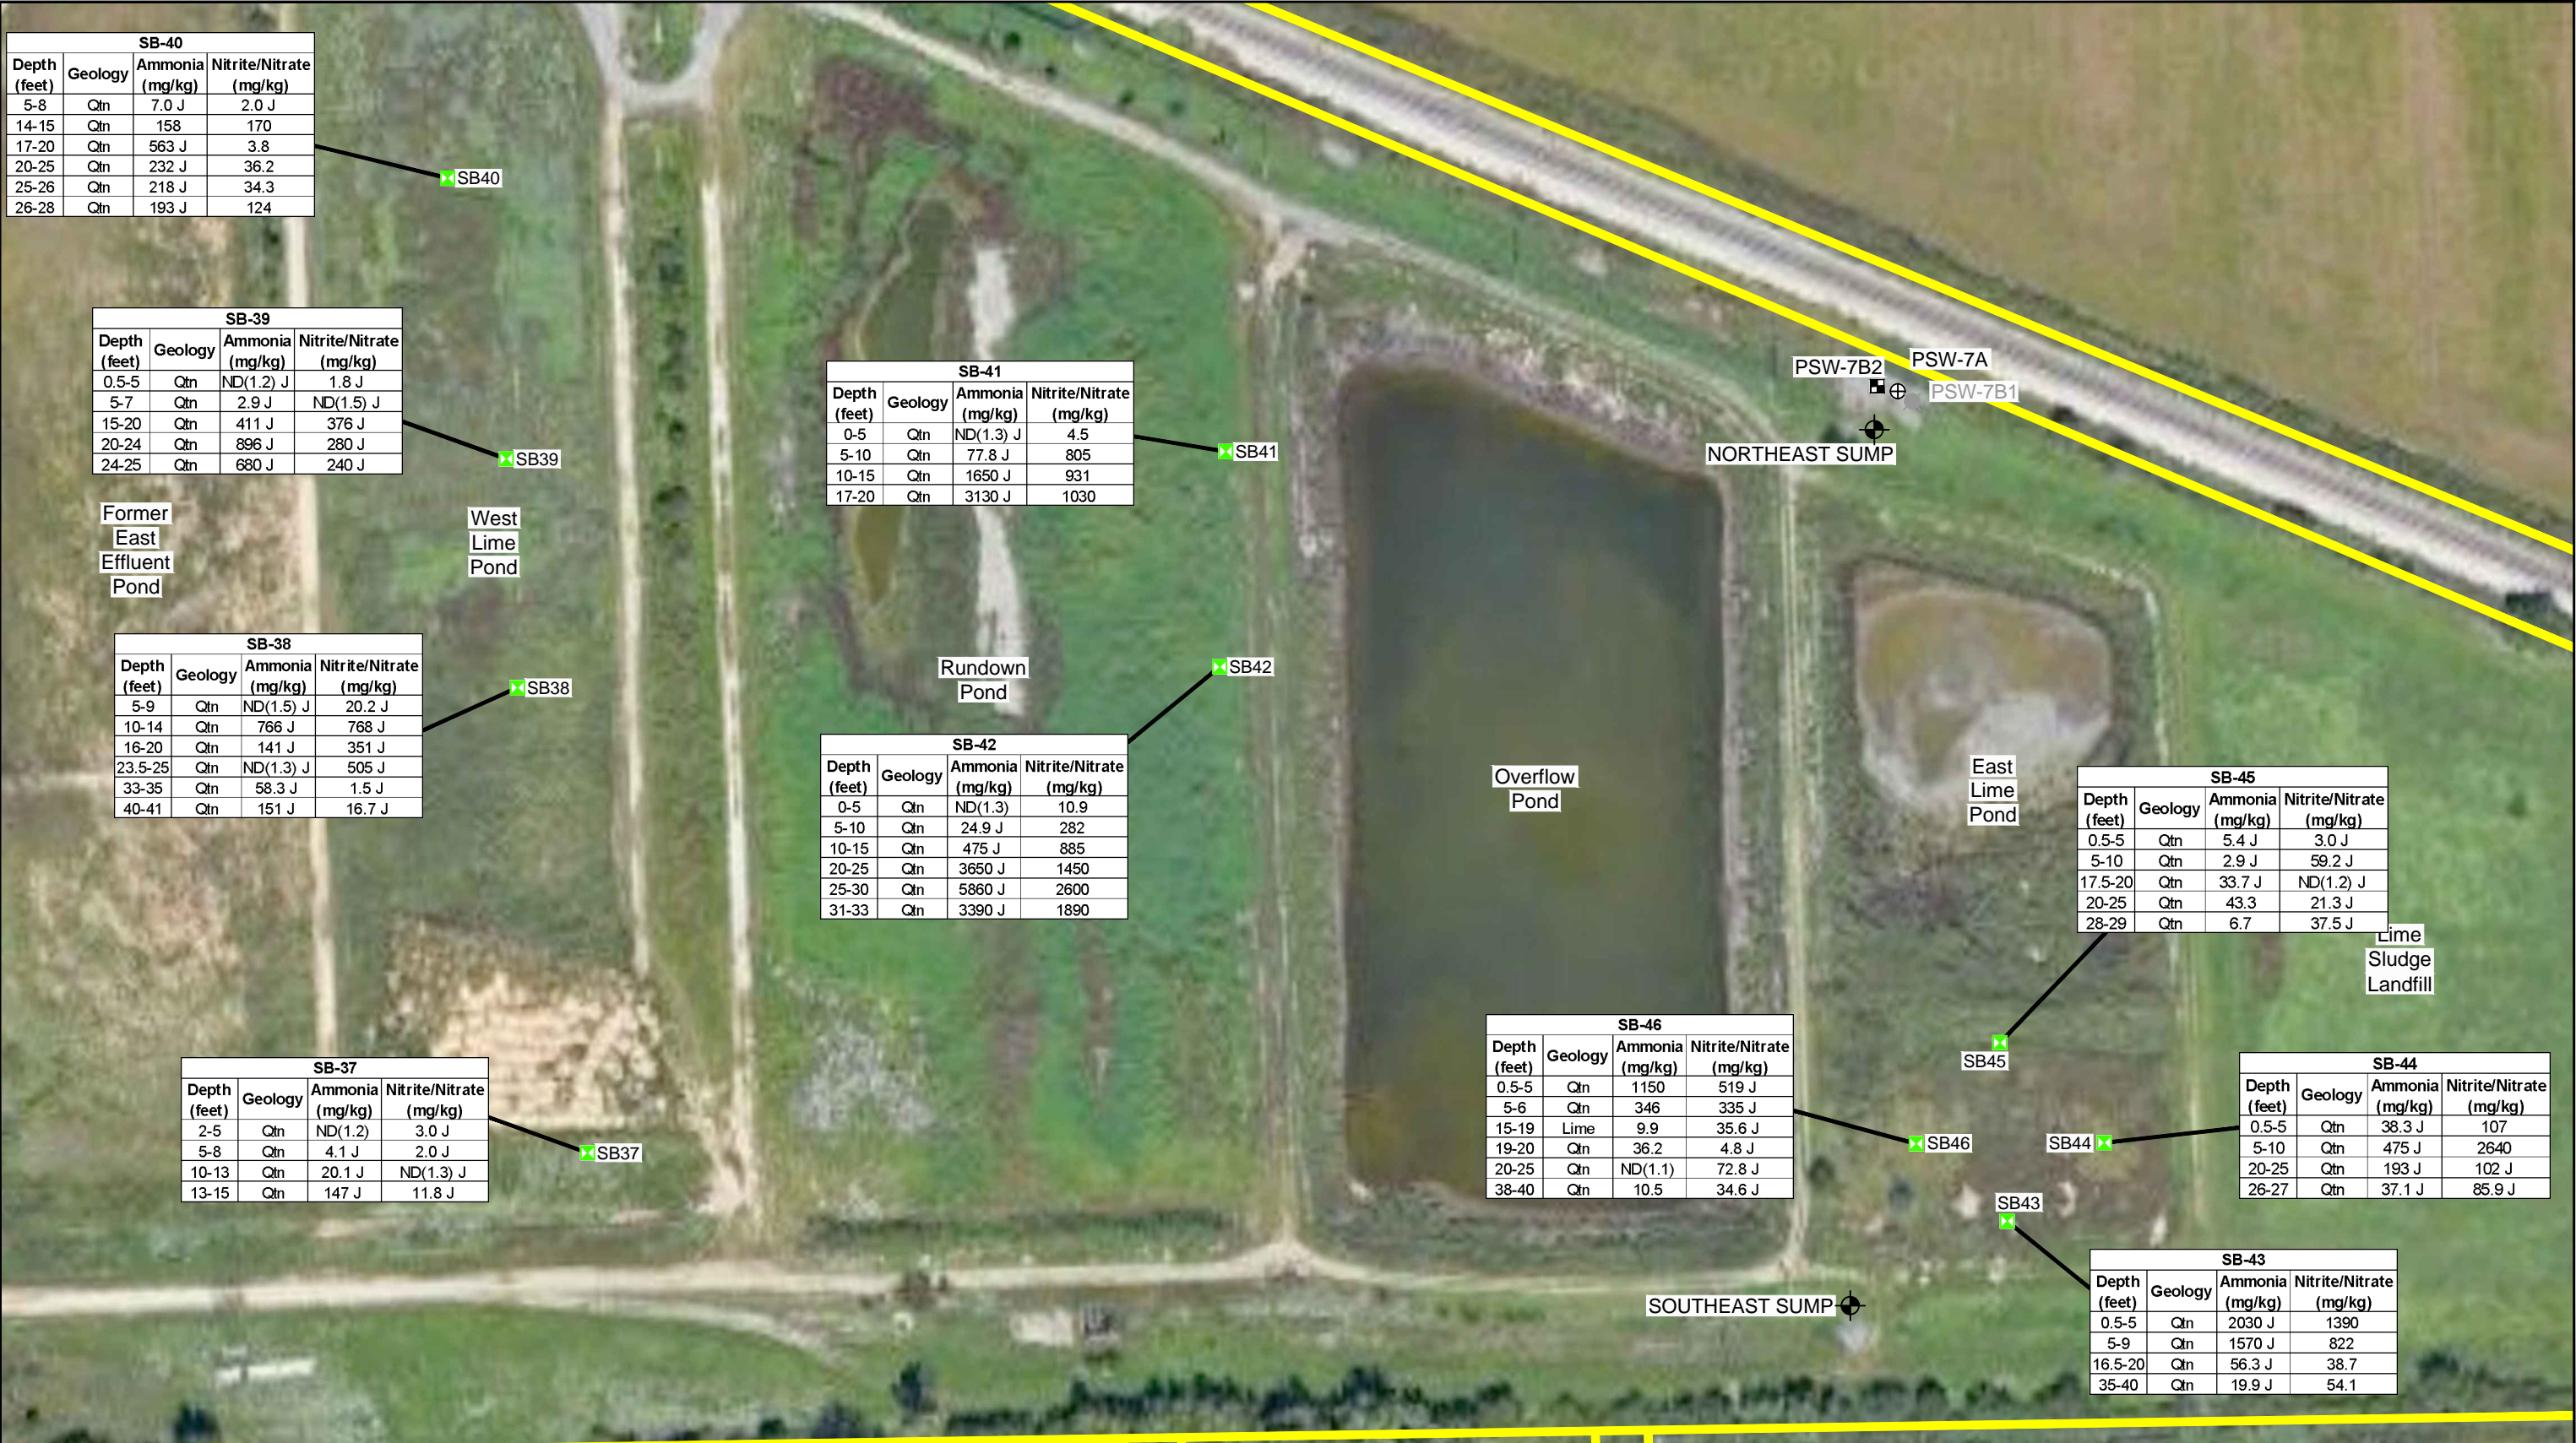
FIGURE 5

Soil sample results from the East Lime Pond, West Lime Pond, and Rundown Pond in the Eastern Ponds Area are shown on Figure 5. Ammonia concentrations in soil samples collected within the East and West Lime Ponds Area ranged from non-detect (ND) to 5,860 mg/kg with 9 out of 10 borehole locations reporting ammonia above 100 mg/kg. Nitrite/Nitrate concentrations in soil samples ranged from ND to 3,390 mg/kg with every borehole location reporting nitrite/nitrate concentrations above 10 mg/kg. The boreholes from which soil samples contained ammonia and nitrite/nitrate concentrations greater than 1,000 mg/kg include SB-4, SB-42, SB-43, SB-44, and SB-46. In particular the soil samples from the boreholes located within the Rundown Pond showed elevated nitrate and ammonia concentrations starting around 10 feet bgs. The East and West Lime Pond Area shows variable soil impacts with SB-41, SB-42, and SB-43 showing the higher overall nitrogen concentrations compared to other borings in this area with SB-42 and SB-43 exhibiting higher nitrogen concentrations at depths greater than 10 feet bgs.

Within the Eastern Pond Area, Rundown Pond and East Lime Pond sample locations SB-41, SB-42, SB-43, and SB-46 had ammonia and nitrite/nitrate concentrations greater than 1,000 mg/kg. Sample locations SB-41 and SB-42 are located within the Rundown Pond and had concentrations greater than 1,000 mg/kg between 10 to 33 feet bgs. The SB-43 and SB-46 sample locations are located within the East Lime Pond and had concentrations greater than 1,000 mg/kg between 0.5 to 9 feet bgs. The elevated samples were found within or near these former pond bottoms. For the East Lime Pond, concentrations decrease with depth. Whereas, at the Rundown Pond the highest concentrations are found near the pond bottom. At the West Lime Pond, the overall ammonia and nitrate concentrations tend to be less compared to the Rundown Pond and East Lime Pond.

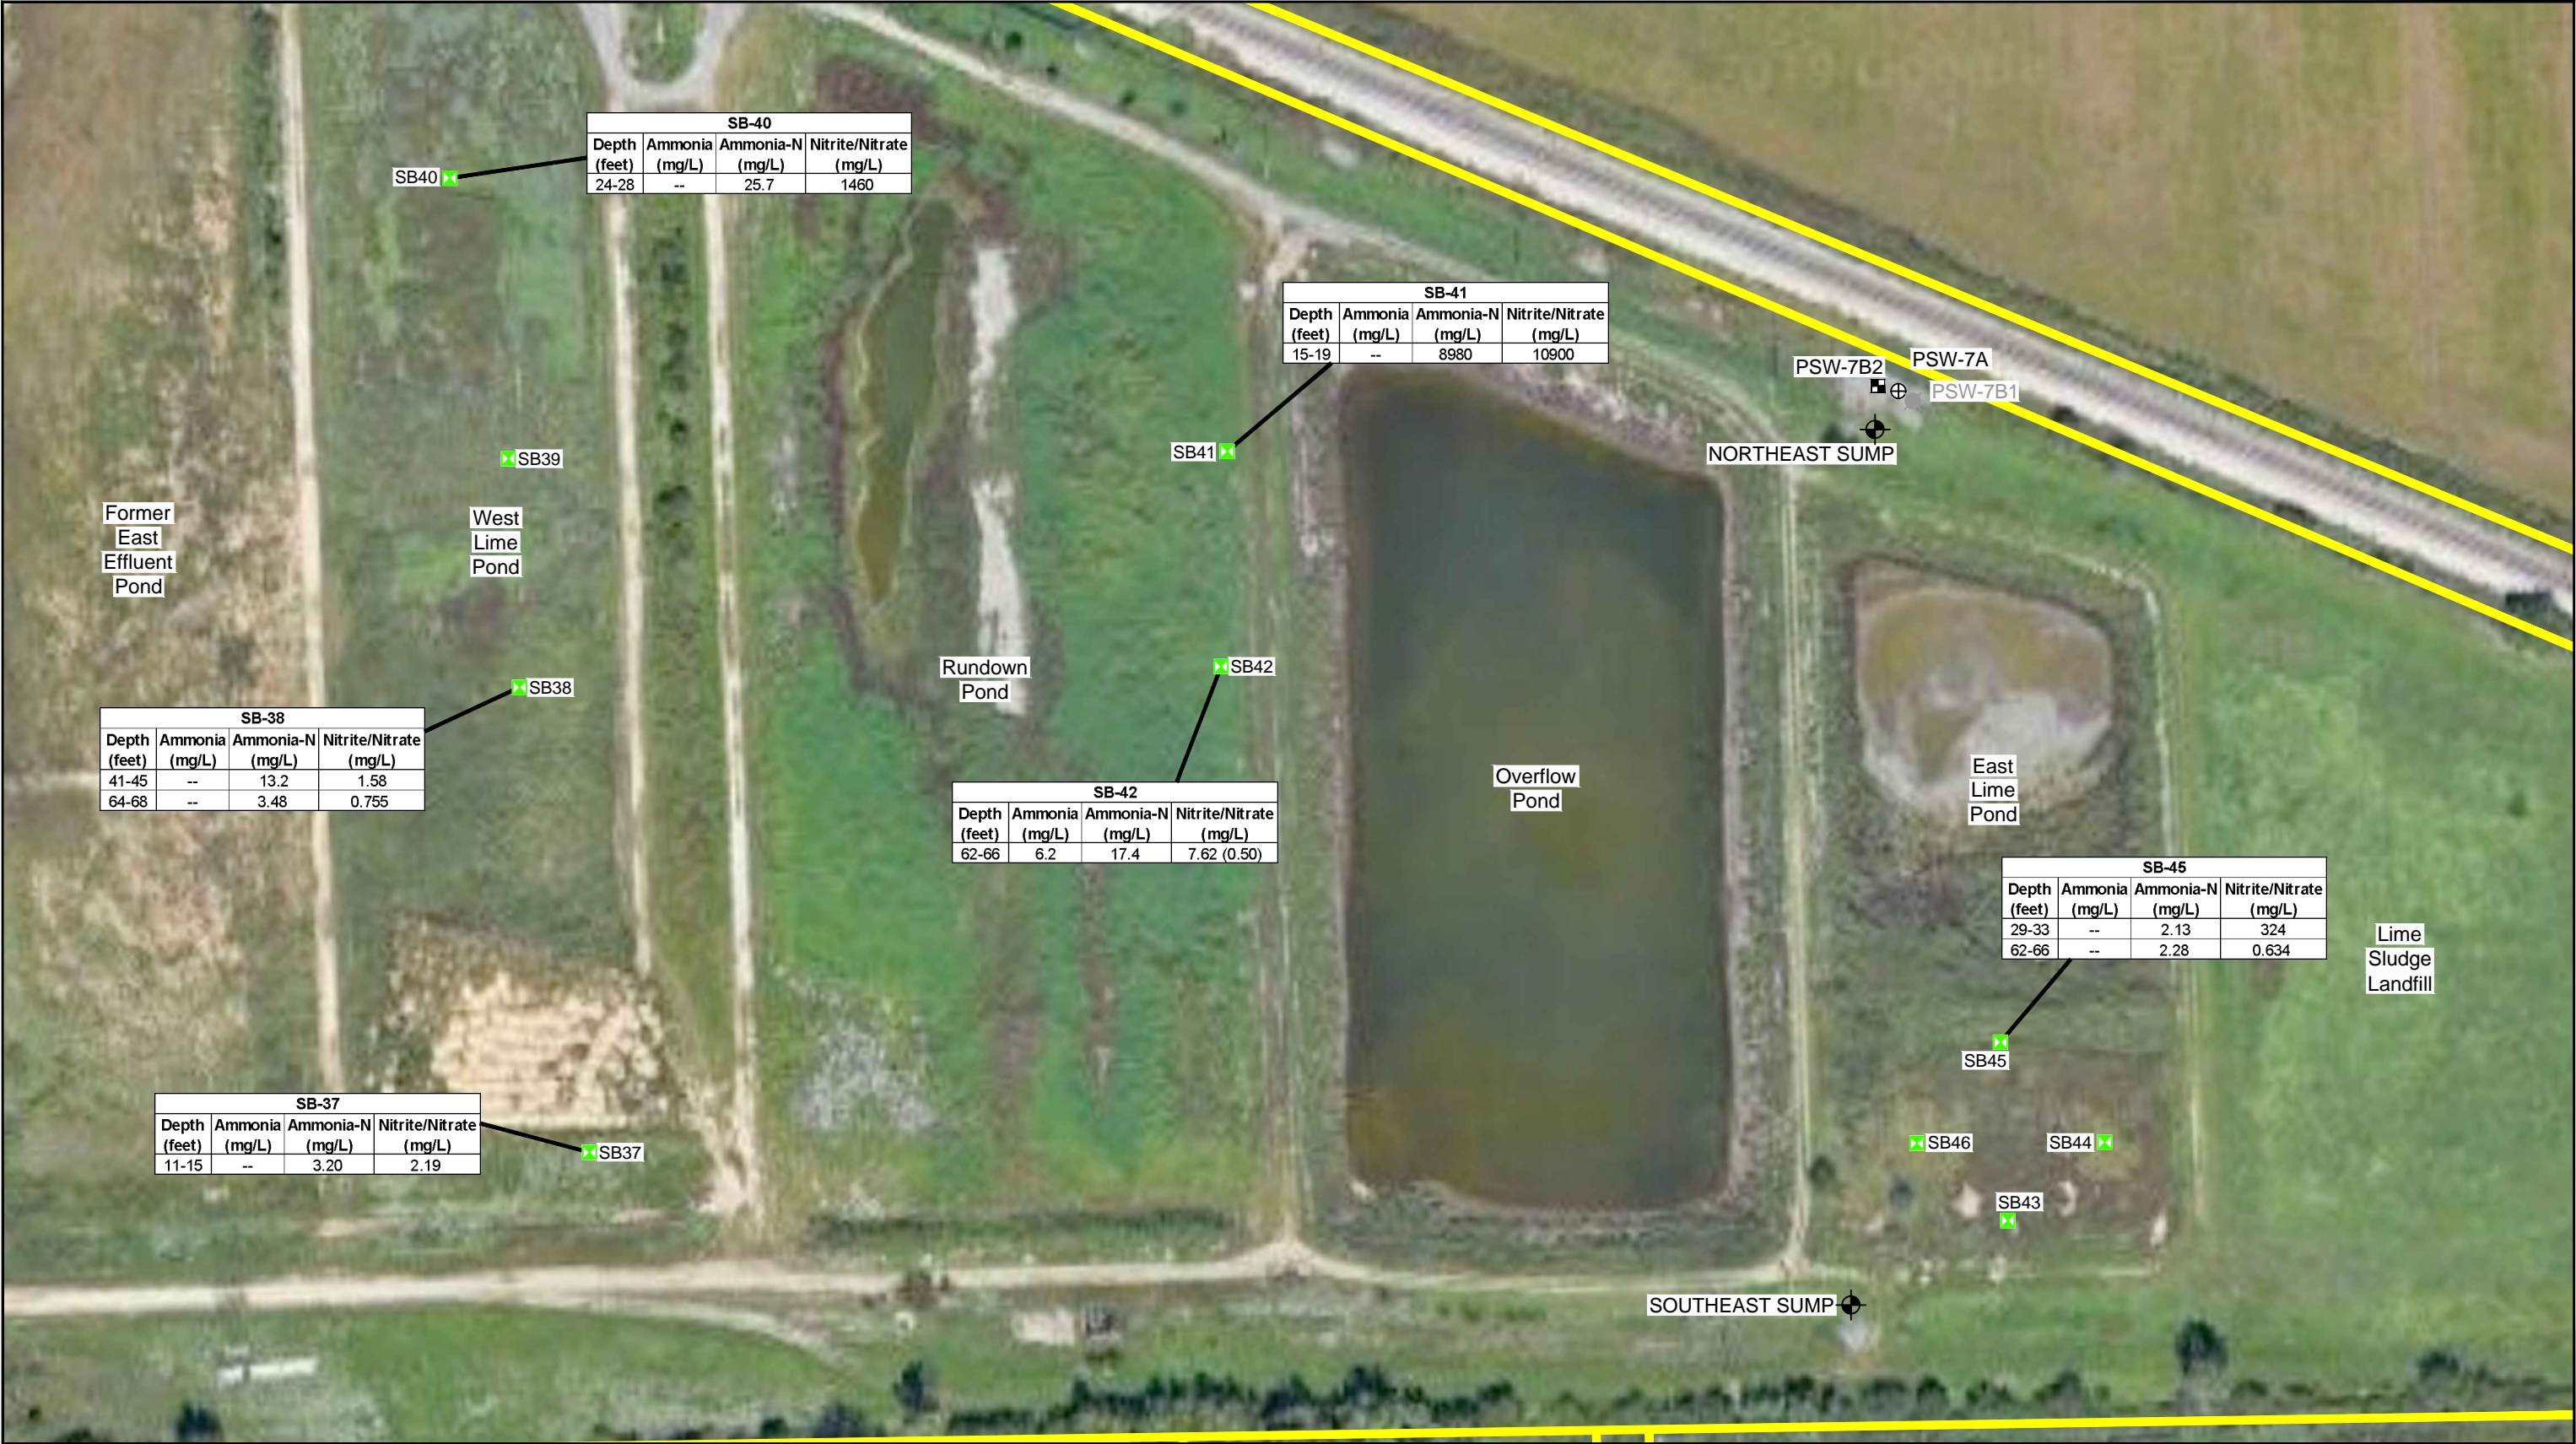
GROUNDWATER SAMPLING RESULTS - WEST EXTENSION POND **FIGURE 7**

Groundwater sample results from the West Extension Pond in the Western Ponds Area are shown on Figure 7. Ammonia concentrations in groundwater samples collected from within the West Extension Pond Area ranged from 14.6 mg/L to 20,400 mg/L. All sample locations reported elevated ammonia. Nitrite/Nitrate concentrations in groundwater samples collected within the West Extension Pond Area ranged from 1.36 mg/L to 23,200 mg/L. All locations had exceedances nitrite/nitrate greater than 10 mg/L, with the exception of SB-31 and SB-34. The SB-36 location had the highest ammonia and nitrite/nitrate concentrations of 20,400 mg/L and 23,200 mg/L, respectively at 31 to 35 feet bgs. The West Extension Pond Area reported the highest dissolved nitrogen concentrations under the DGS with several locations showing elevated nitrate concentrations (> 500 mg/L) at depths greater than 50 feet bgs.
