City of Lawrence

# Lawrence Field Operations Facility

## Existing Facility Condition Narratives

DAKE | WELLS  
architecture

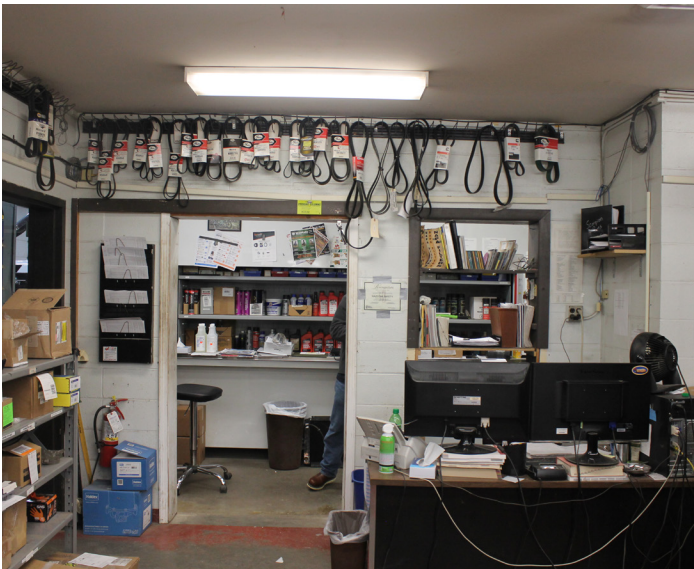
Concrete floor, painted CMU walls, gyp board ceiling, surface mounted fixtures, poor condition

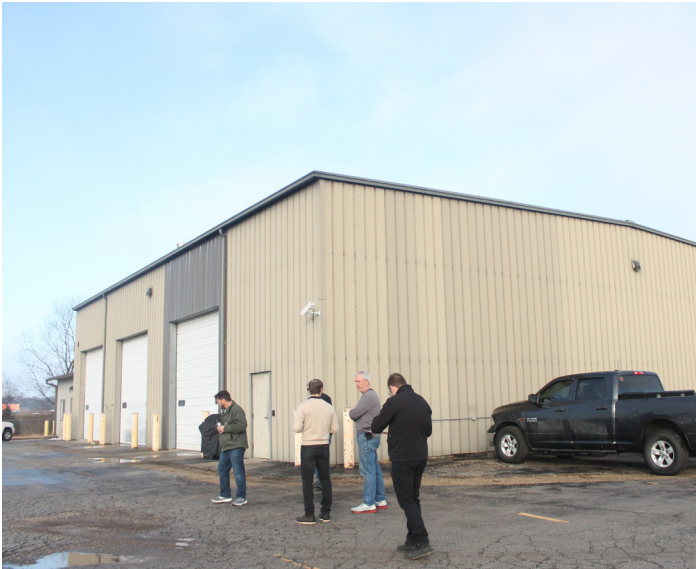
Exterior - fair condition

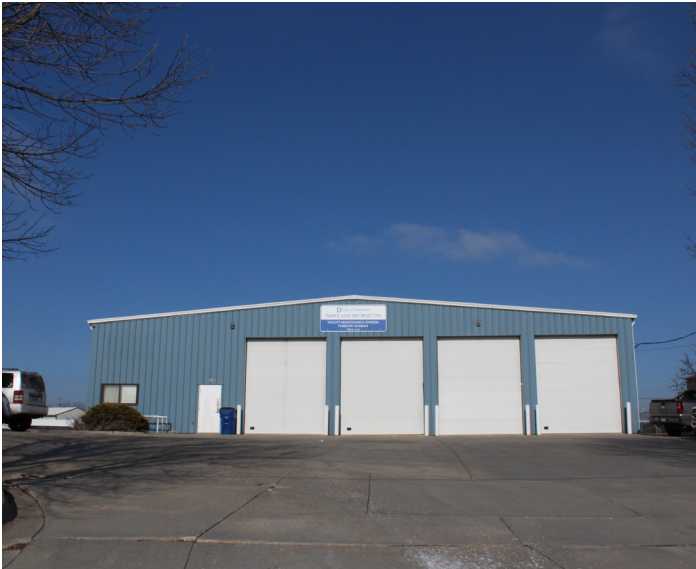
Exterior - good condition

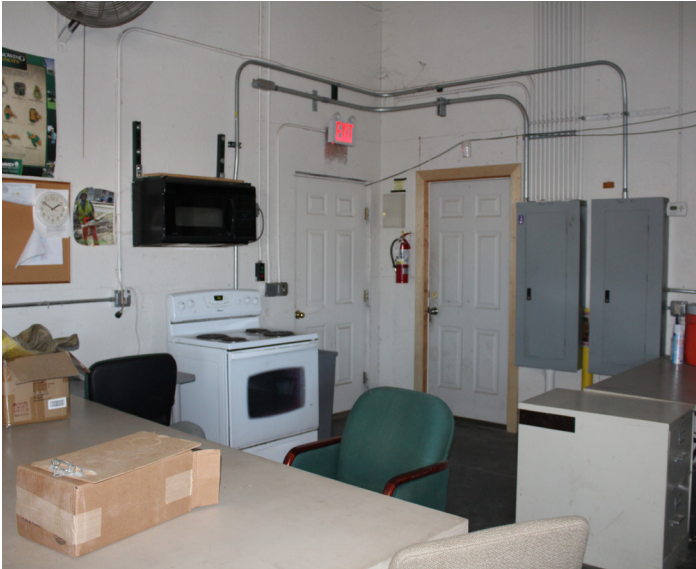
Concrete floor, gypsum board walls, poor condition

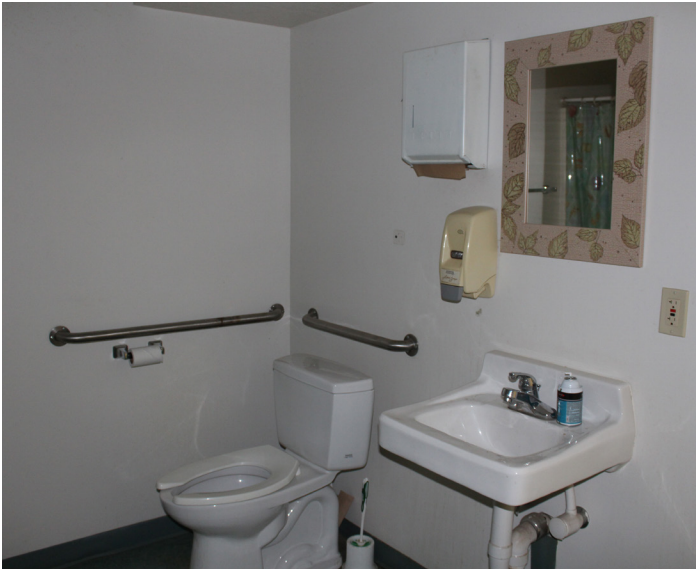
ADA accessible restroom, gypsum board walls

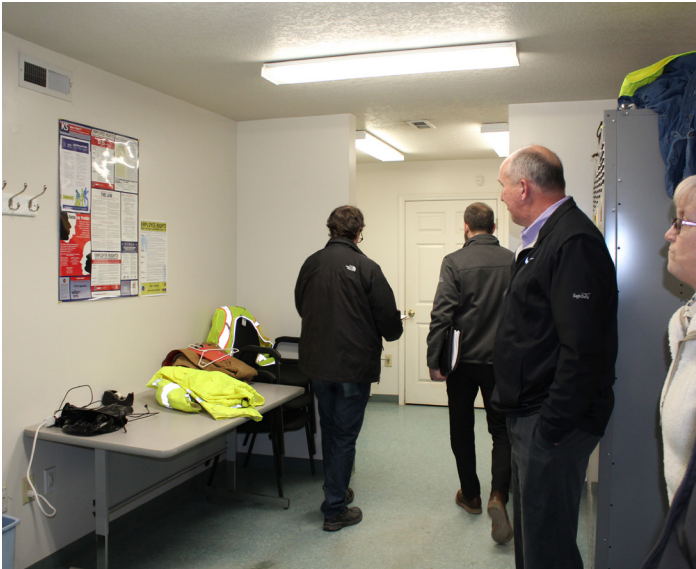
Linoleum flooring, gypsum board walls, popcorn ceiling, surface mounted fixtures,

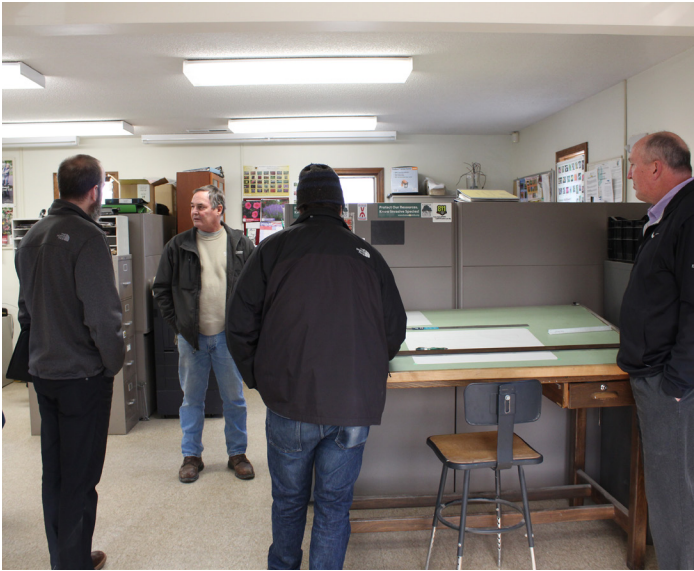
Linoleum flooring, painted gypsum board walls, popcorn ceiling, surface mounted fixtures

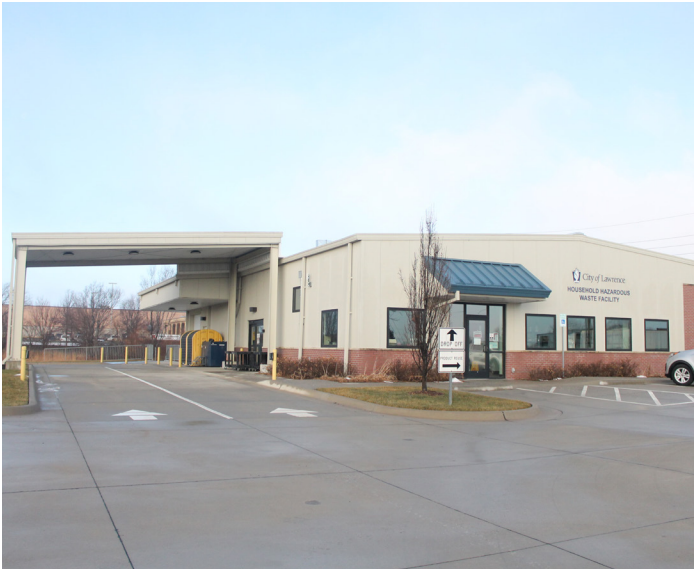
Exterior - good condition

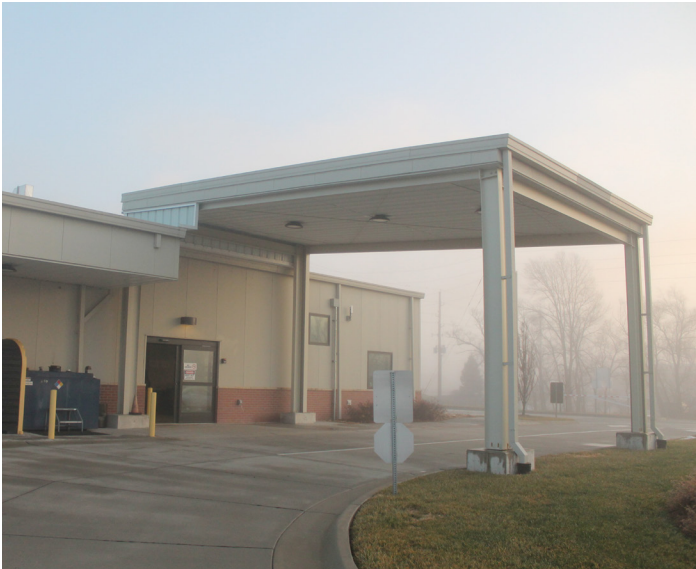
Exterior - good condition

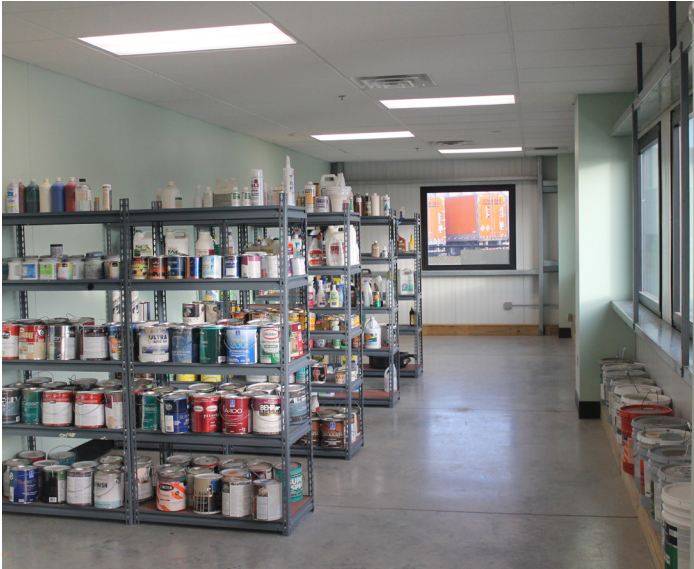
Concrete floor, painted gypsum board walls, ACT tile ceiling, good condition

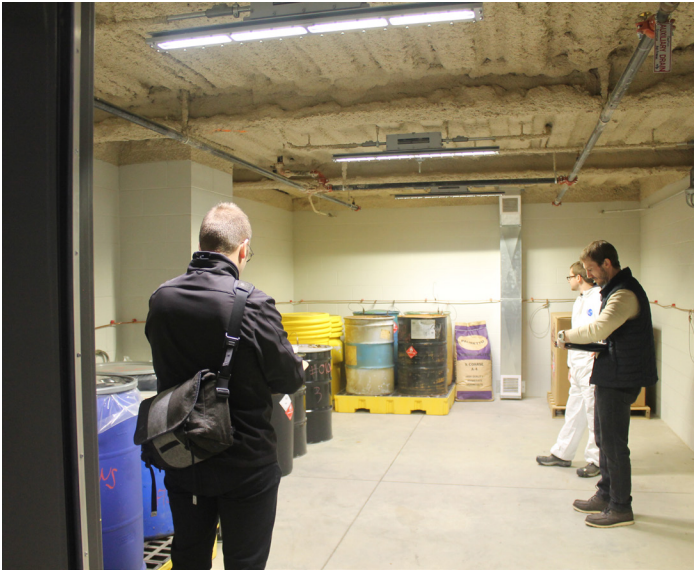
Concrete floor, painted CMU walls, good condition

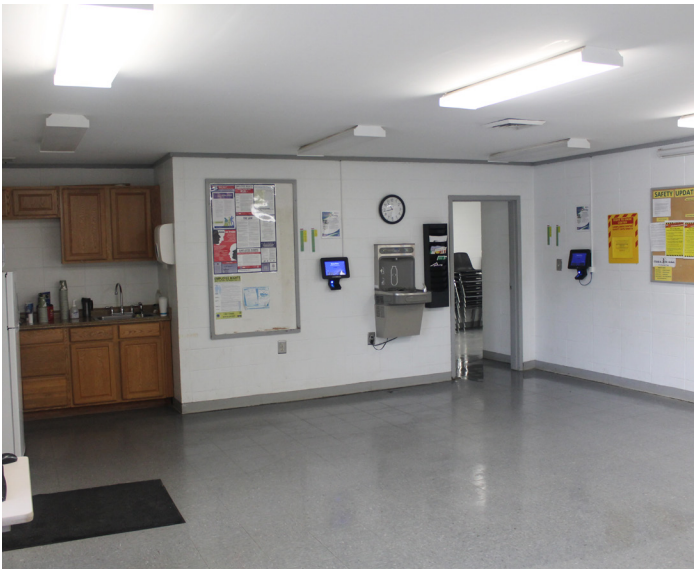
Linoleum flooring, painted CMU walls, gypsum board ceiling, surface mounted fixtures, fair condition

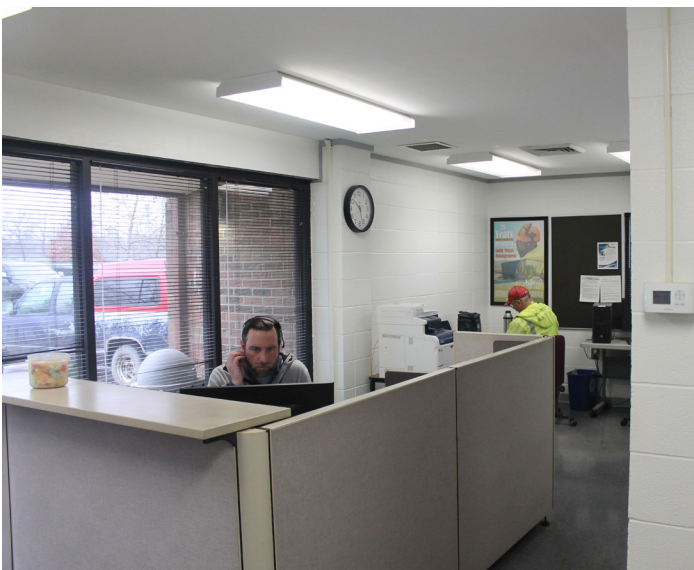
Linoleum flooring, painted CMU walls, gypsum board ceiling, surface mounted fixtures

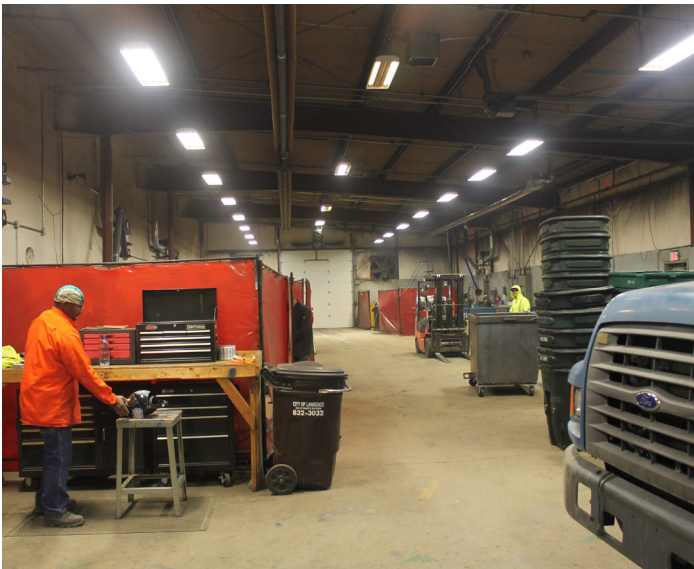
Concrete floor, pre-engineered steel structure

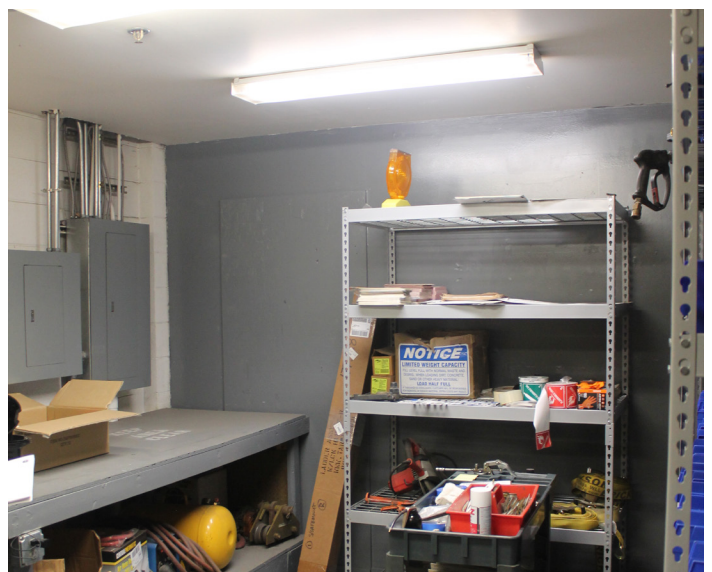
Concrete floor, painted CMU walls, gypsum board ceiling, surface mounted fixtures

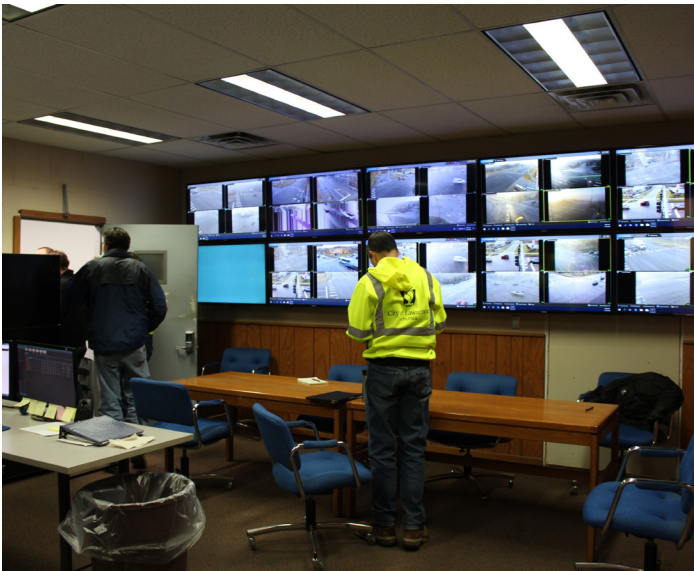
Carpet floor, painted CMU walls, decorative wood wall panel, ACT ceiling, poor condition

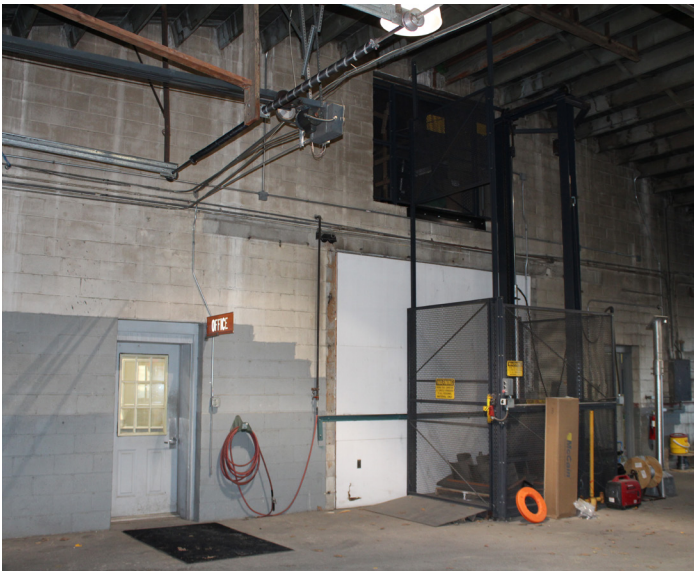
Concrete floors, partially painted CMU walls, exposed structure, water damage, poor condition

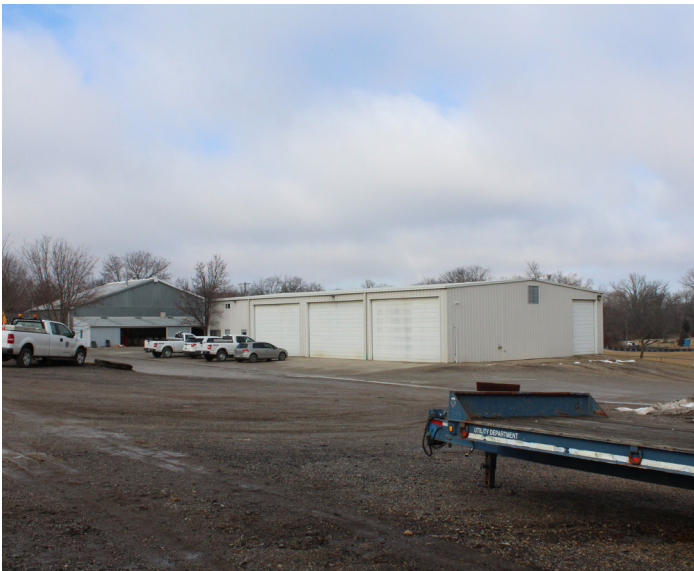
Exterior - fair condition

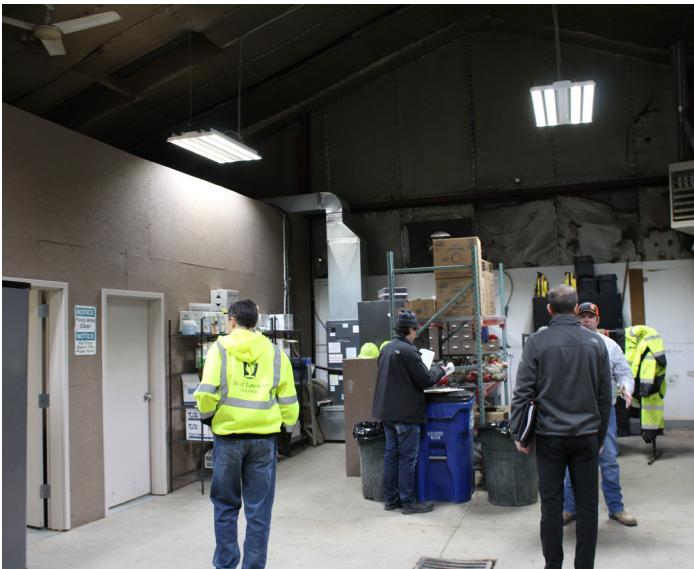
Concrete floor, damaged insulation, overall poor condition

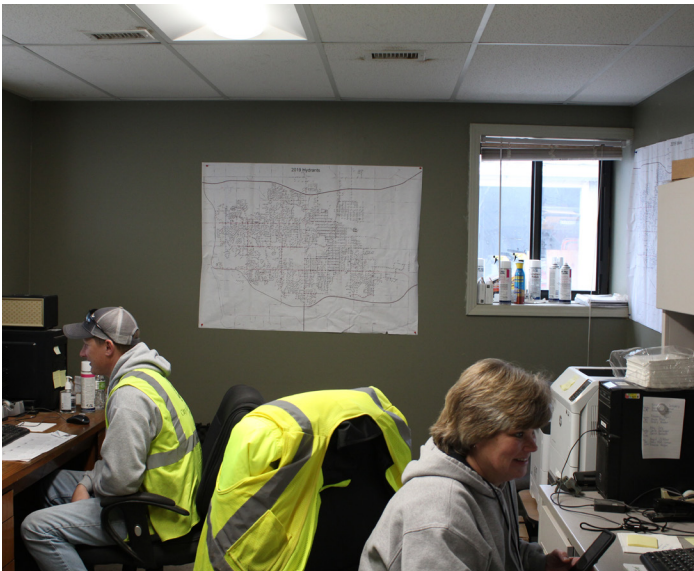
Concrete floor, painted gypsum board walls, ACT ceiling, fair condition

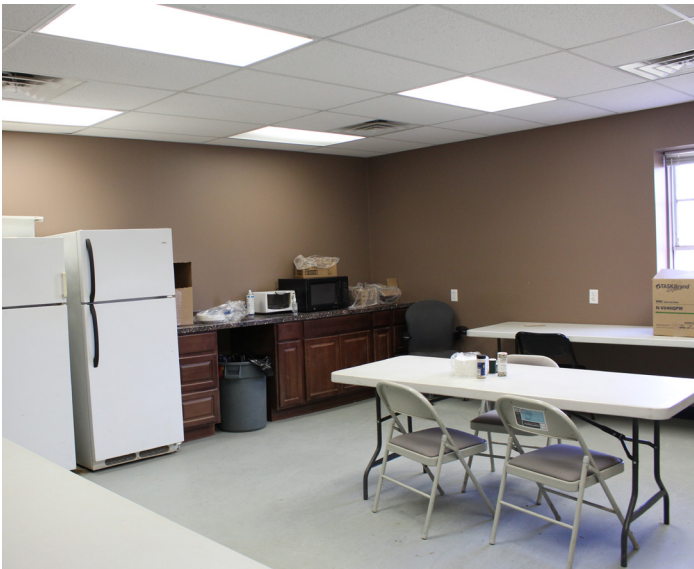
Concrete floor, painted gypsum board walls, ACT ceiling, good condition

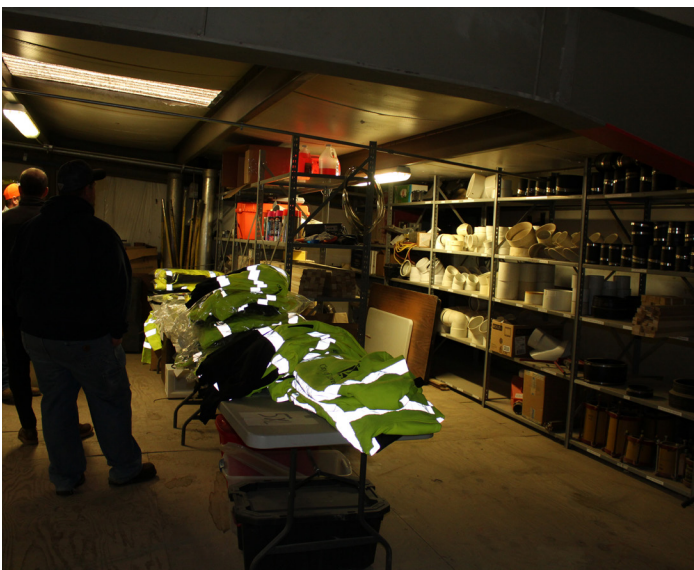
Concrete floor, steel structure, bag insulation, overall poor condition
