City of Lawrence

# Lawrence Field Operations Facility

## Existing Facility Condition Narratives

DAKE | WELLS  
architecture

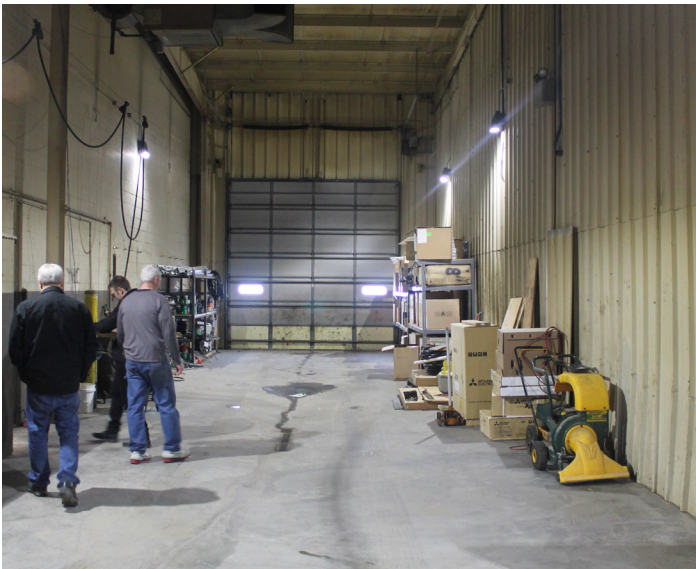
Concrete floor, exposed pre-engineered steel structure, poor condition

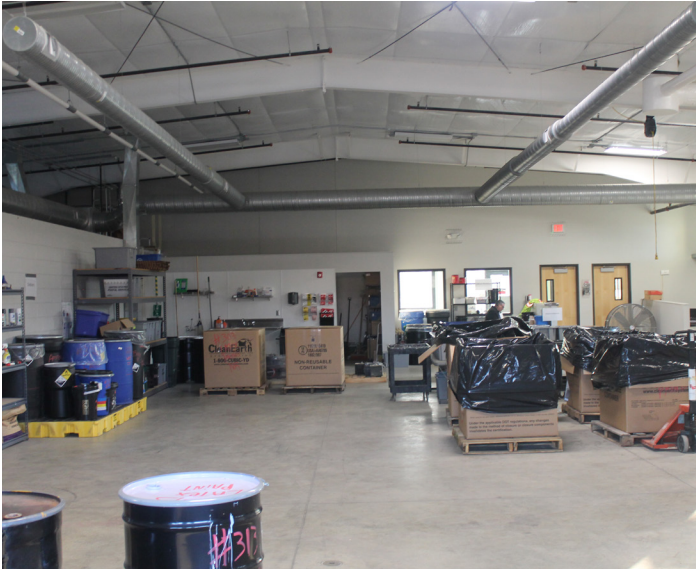
Concrete floor, pre-engineered steel structure, bag insulation, good condition

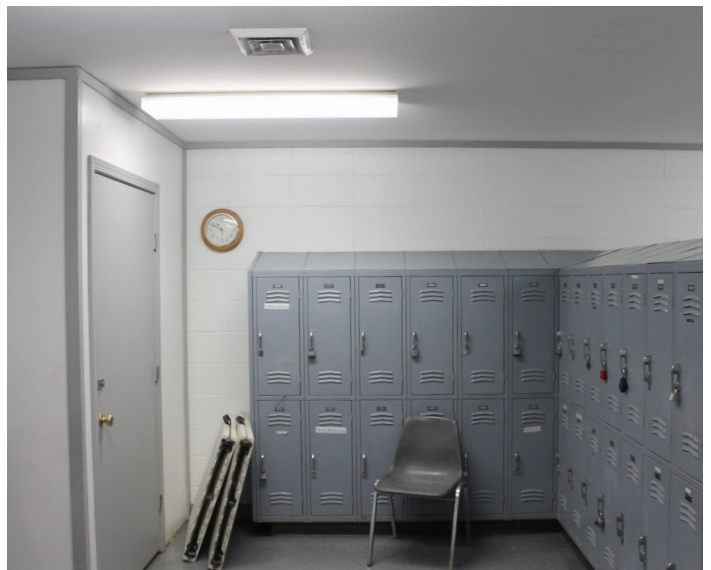
Linoleum flooring, painted CMU walls gypsum board ceiling, surface mounted fixtures

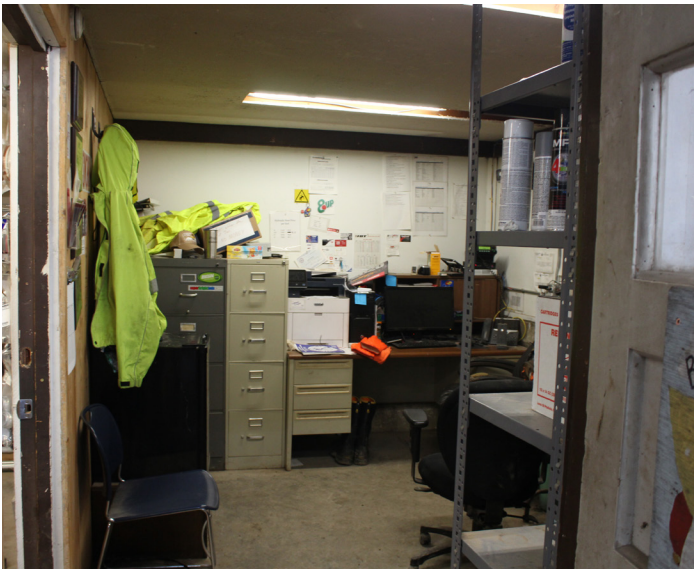
Concrete floor, surface mounted fixtures, overall poor condition
